# Church of St Mary, Bletsoe Bedfordshire

**Trial trenches December 2014 / January 2015**

March 2015 - final draft

## **Trial trenches December 2014 / January 2015**

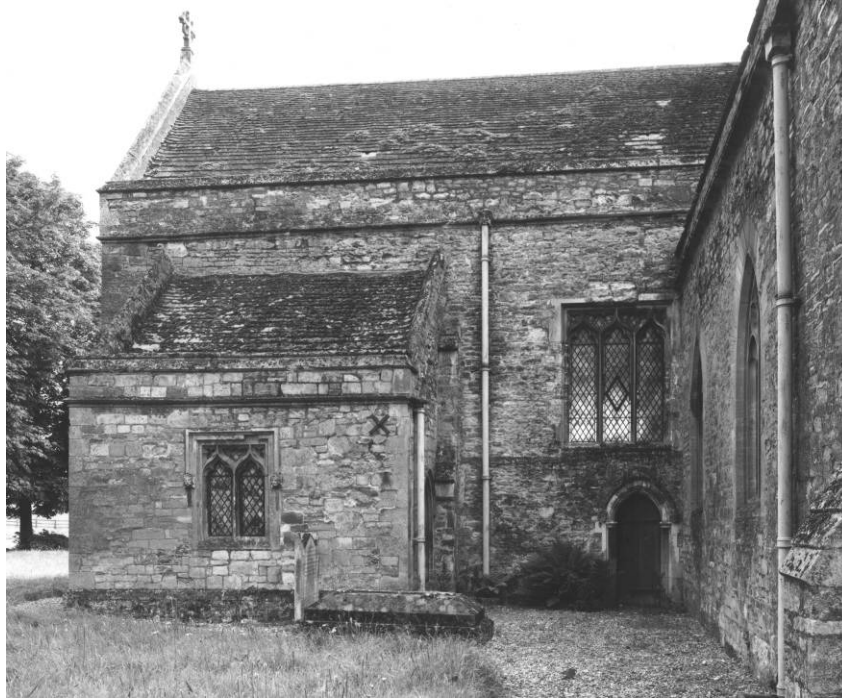
**Fig 3** N side of chancel and 19-century vestry in the mid 1970s before roof repair / removal, showing the site of the proposed lobby

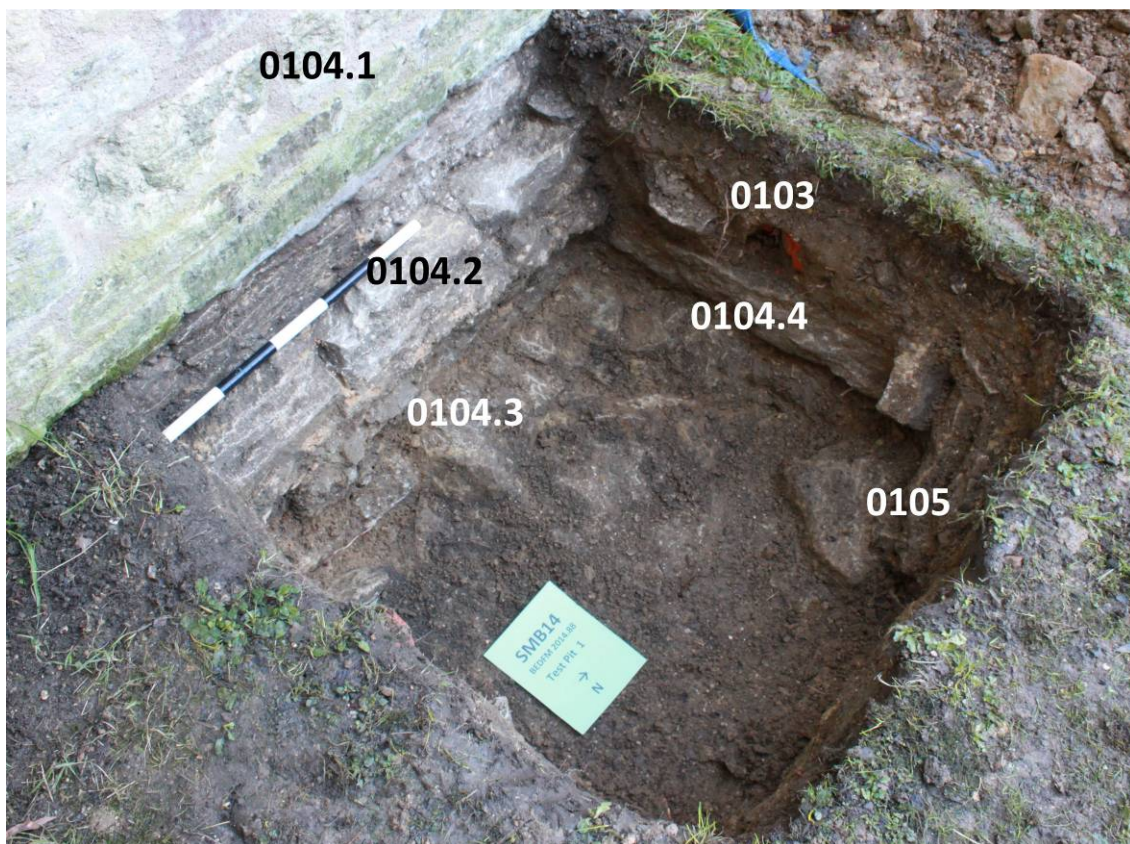
### ***SMB14-1: against north transept (Fig 7)***

4.3 About 15cm of topsoil (0101) lay over about 30cm of yellow clayey earth (0102) with some small rubble. Within the latter was a modern red tile drain (0103) running south-north, its mid-point 42cm east of the north transept wall. The yellow clayey earth lay over a mixed layer of mortar, clay and large pieces of limestone rubble (0105), not fully excavated at 60cm below modern ground level.

4.4 The east wall of the transept (0104.1) had one course 15cm thick below modern ground level standing on a 10cm wide offset (0104.2), the southernmost stone of which was chamfered. The offset was of roughly coursed rubble and itself stood on a further 28cm wide offset (0104.3) at a depth of 50cm below modern ground level. Apparently bonded into this offset and in the north section of the trench was the side of a large stone structure (0104.4), covered in the north-east corner of the trench by loose large pieces of limestone rubble.

4.5 The only obstacle to the required ground level reduction indicated by this trench is the aforementioned large stone structure, if it runs as far east as the lower part of the path down to the lobby entrance. Significant amounts of rubble might be expected; dating evidence, if recovered, may show it belongs to the major 19th-century restoration of the north transept rather than to any earlier or original construction phase.

***Fig 7 SMB14-1 facing NW, showing wall offsets at left and tile drain over large stone structure in north section at right, scale 50cm***

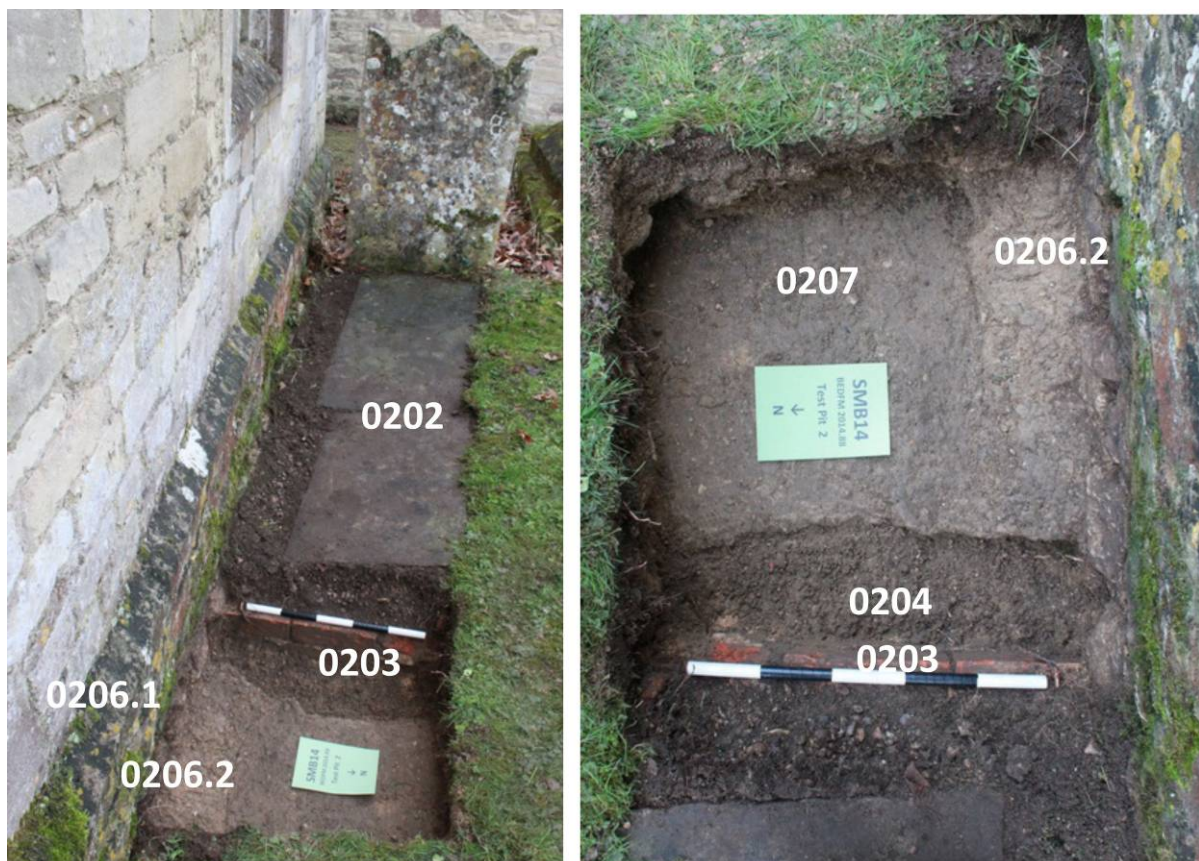
***SMB14-2: against north wall of vestry (Fig 8)***

4.9 Trench 2, 87 x 63cm was excavated against the external north side of the vestry in order to assess the foundations. An intention to place it centrally on the wall was thwarted by two grave slabs laid flat along the wall immediately east of the headstone to Antonia (d 1844) and Hester Bainbridge.

4.10 About 5cm of topsoil and gravel (0201) covered the grave slabs (0202) and yellow mortar rubble (0205) in the rest of the trench. Just east of the end of the grave slabs was a row of bricks (0203) indicating the east end of a vault abutting the vestry wall. At 25cm below modern ground surface the vestry wall had a rough offset plinth (0206.2) about 13cm wide, itself sitting on a hard stone and mortar surface (0207). On first sight and in a limited space the vault seemed to have been cut into the offset foundation of the vestry wall. But if the date on the headstone refers to the vault it would have been constructed first and the vestry fitted between it and the side of the chancel.

4.11 Subject to architectural assessment, and even though this trench could not be excavated to 60cm depth, the indications are that the foundations are adequate on this north side, especially bearing in the extent of foundation found inside the vestry (SMB14-4 below).

***Fig 8 SMB14-2 north exterior face of vestry: left facing west, right vertical; scale 50cm***

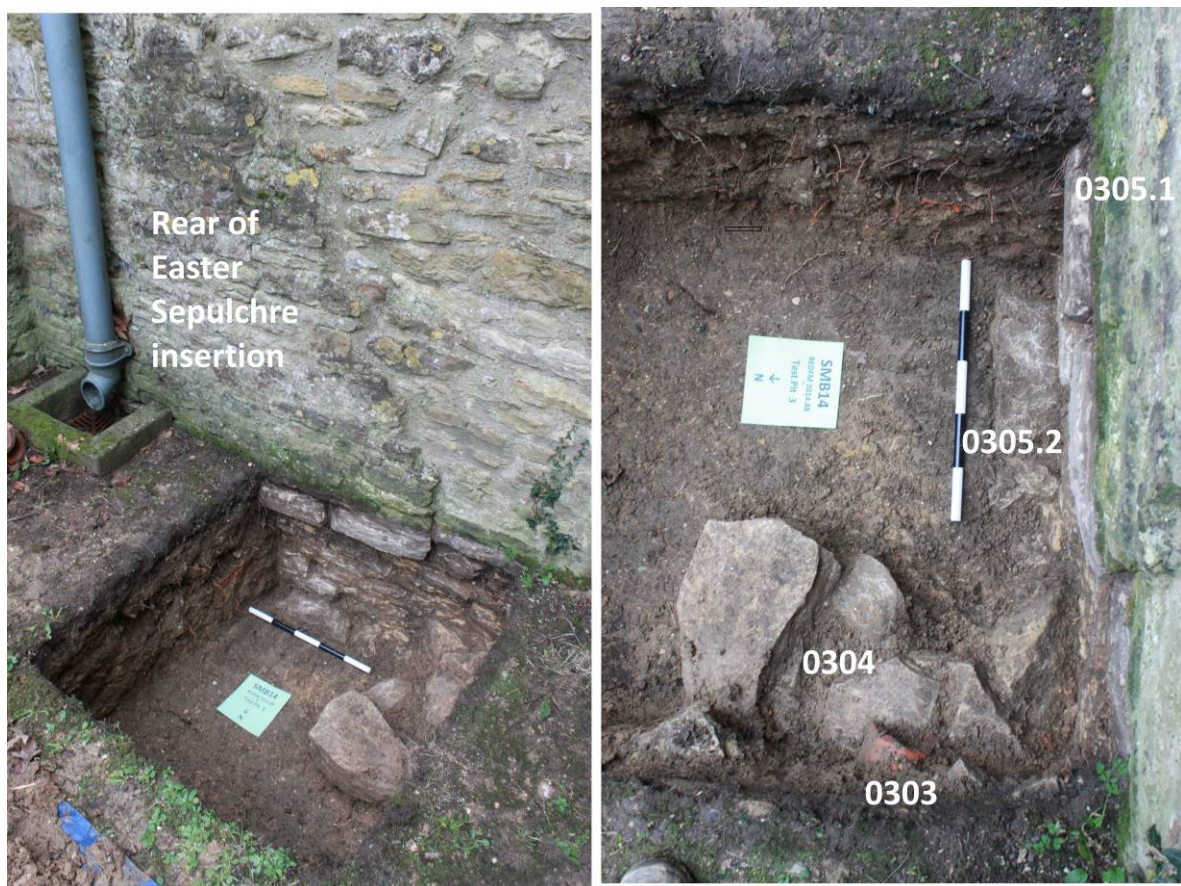
### ***SMB14-3: against chancel (Fig 9)***

4.6 Up to 12cm of topsoil (0301) lay over mixed mortar earth and some clay (0302), not fully excavated at a depth of 56cm. Within the latter was a modern drain, presumably running east-west and joining up with that found in Trench 1. Not easily distinguishable from 0302 was a pile of large limestone pieces (0304) in the south-west corner of the trench, and probably equivalent to the rubble found in Trench 1 (0105).

4.7 Six rubble courses of the chancel wall (0305.1) below modern ground surface sat on a 12cm wide offset at 56cm depth (0305.2). The two large stones visible just below modern ground level are offset slightly forward and at an angle from the main footing underneath. Initially this was thought to indicate the 14th century rebuilding of the chancel wall on a slightly different alignment to its presumed predecessor. However, this curving join in the wall superstructure clearly represents the Easter Sepulchre set into the southern side of the north chancel wall; when it was built, the northern side of the wall was also rebuilt, effectively obscuring any relationship between an earlier and a later footing.

4.8 This trench has not produced any evidence for obstacles to ground reduction by 60cm, though substantial limestone rubble might be expected.

**Fig 9 SMB14-3:** left, facing south east; right vertical: showing rubble, chancel wall offset and construction join for Easter Sepulchre.; scale 50cm

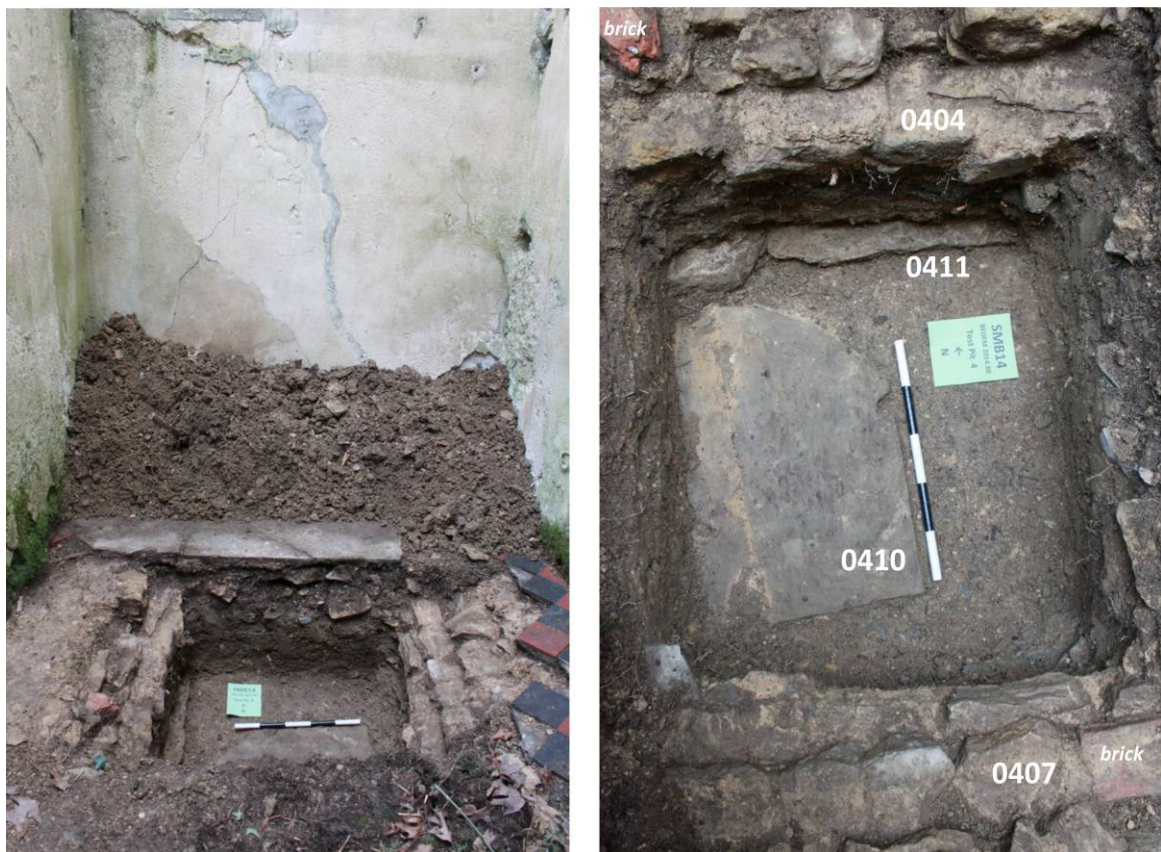
#### ***SMB14-4: vestry interior (Fig 10)***

4.13 An unexpected discovery was a broad yellow mortared footing (0404) immediately under the plain tiles on the north side, extending some 60cm into the middle of the vestry. Extension of the trench showed a similar arrangement about 70cm wide (0407) on the south side. Both footings had pieces of brick in their top courses so are probably mid -19th-century in date rather than reused medieval foundations. If that is the case, the purpose of the southern footing, which presumably abuts the north chancel wall, is unclear, and the placing of the upstanding north wall on the north side of the northern footing appears to be an attempt to squeeze the maximum width between the chancel and the Bainbridge vault (see above trench 2, fig 8).

4.14 The area in between these footings was excavated to 53cm. The upper fill under where the tile floor had already been removed was loose yellow mortar and rubble (0405) up to 18cm deep, coming down on to a bitumen-like surface (0406) at 22cm below the top of the concrete slab visible in the photograph below, on a yellow mortar seating (0408). This was laid across the top of the lower courses of the adjacent footings, so is presumably also mid C19 and contemporary with them. Below this was a layer of mixed clay, earth and small rubble (0409) coming down at 53cm below the concrete slab on to a headstone with a

**Fig 10 SMB14-4 vestry:** left, facing E, showing footings and excavated area between them; right, facing N at 56cm, showing flat headstone (0410) and lower possible footing (0411): scale 50cm

curved top (0410) lying flat face down. There was a yellow mortar-filled line up the middle indicating either a repair or a fixing against a surface in its original position. The west side of the headstone ran under the trench section so no attempt was made to lift it. At the same level as the headstone a row of flat stones (0411) was seen under and on the same alignment as the footing on the north side: whether it too relates to the later vestry or to its medieval predecessor is unclear.

4.15 Subject to architectural assessment it would seem possible to reduce the ground level in the vestry by removing the upper part of the broad 19th-century footings on either side where they do not appear to have any significant structural function. Its solidity ought to limit the requirement for a full 60cm excavation to the central part.

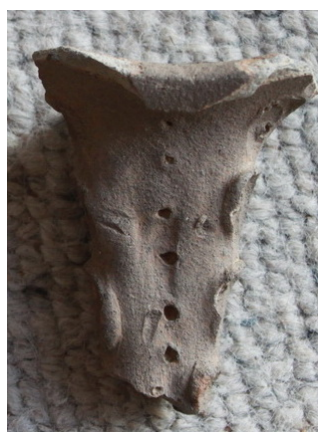
| Context | Description | BFTS | Date |
|---|---|---|---|
| 0302 | jug handle with portion of rim, in late medieval reduced ware | E01 | C14 – C15 |

A 0302 – jug handle

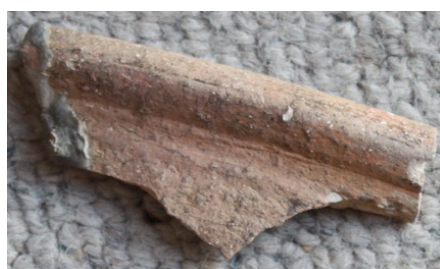
| Context | Description | BFTS | Date |
|---|---|---|---|
| 0409 | cooking pot rim, in medieval shelly ware (developed St Neots) | B07 | C12 – C13 |

B 0409 – cooking pot rim

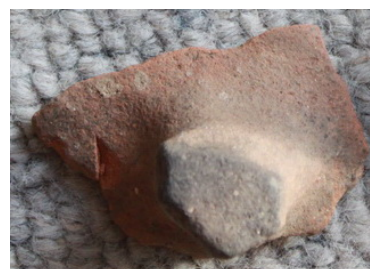
| Context | Description | BFTS | Date |
|---|---|---|---|
| 0409 | pipkin body sherd and tripod foot, in glazed red earthenware | P01 | C17 |

C 0409 – pipkin tripod foot
