**Bletsoe Church from the south-east, Thomas Fisher, c1812**

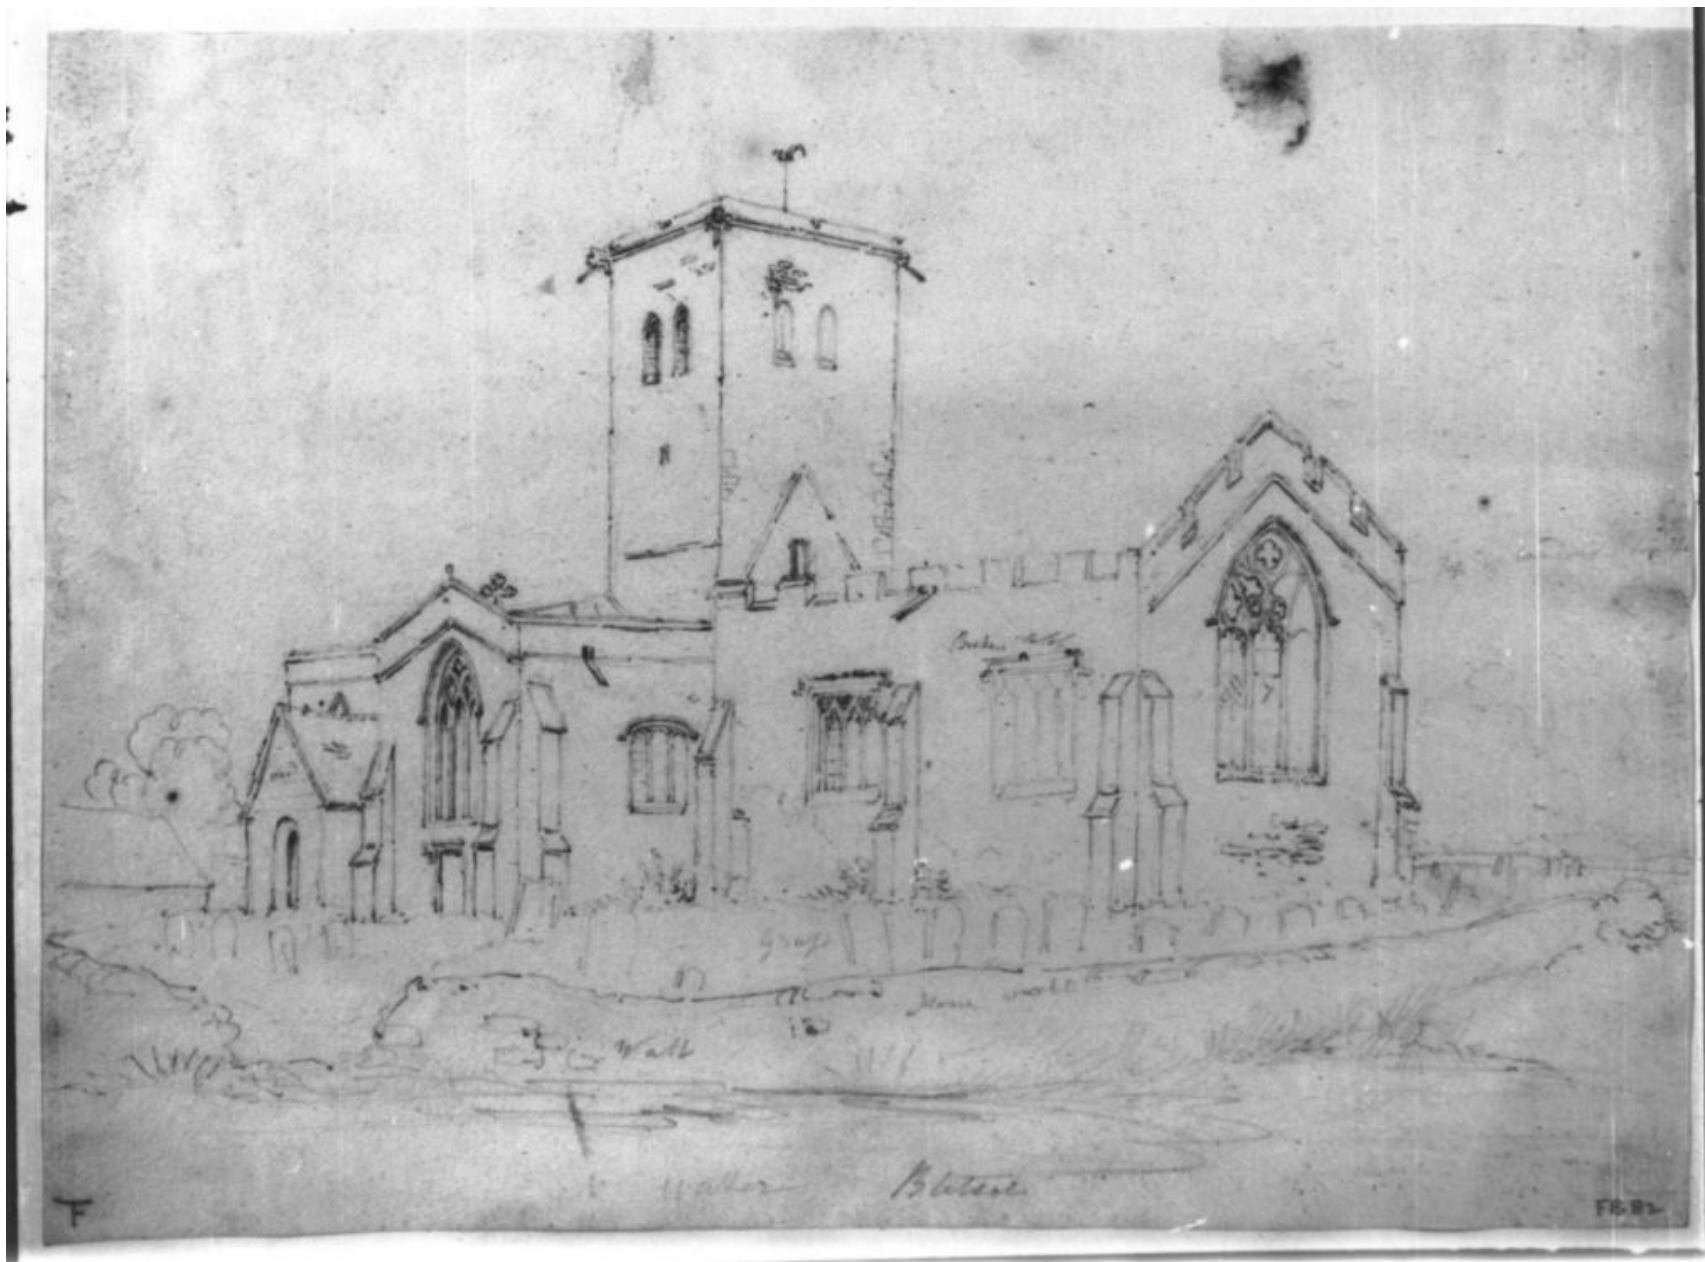
At the 1860s restoration the plain, undecorated south porch will be substantially rebuilt, and the doorway in the end of the south transept blocked up. The crenellated chancel parapet will be removed and shallow roof pitches and gables made steeper. The tower access turret between the chancel and the south transept will be added; also gable finials. Before the building of Bletsoe School in 1851, the south transept was the village schoolroom and Parish Clerk's Office, hence the door in its south wall. **EB14** (BARS Z49-1059)

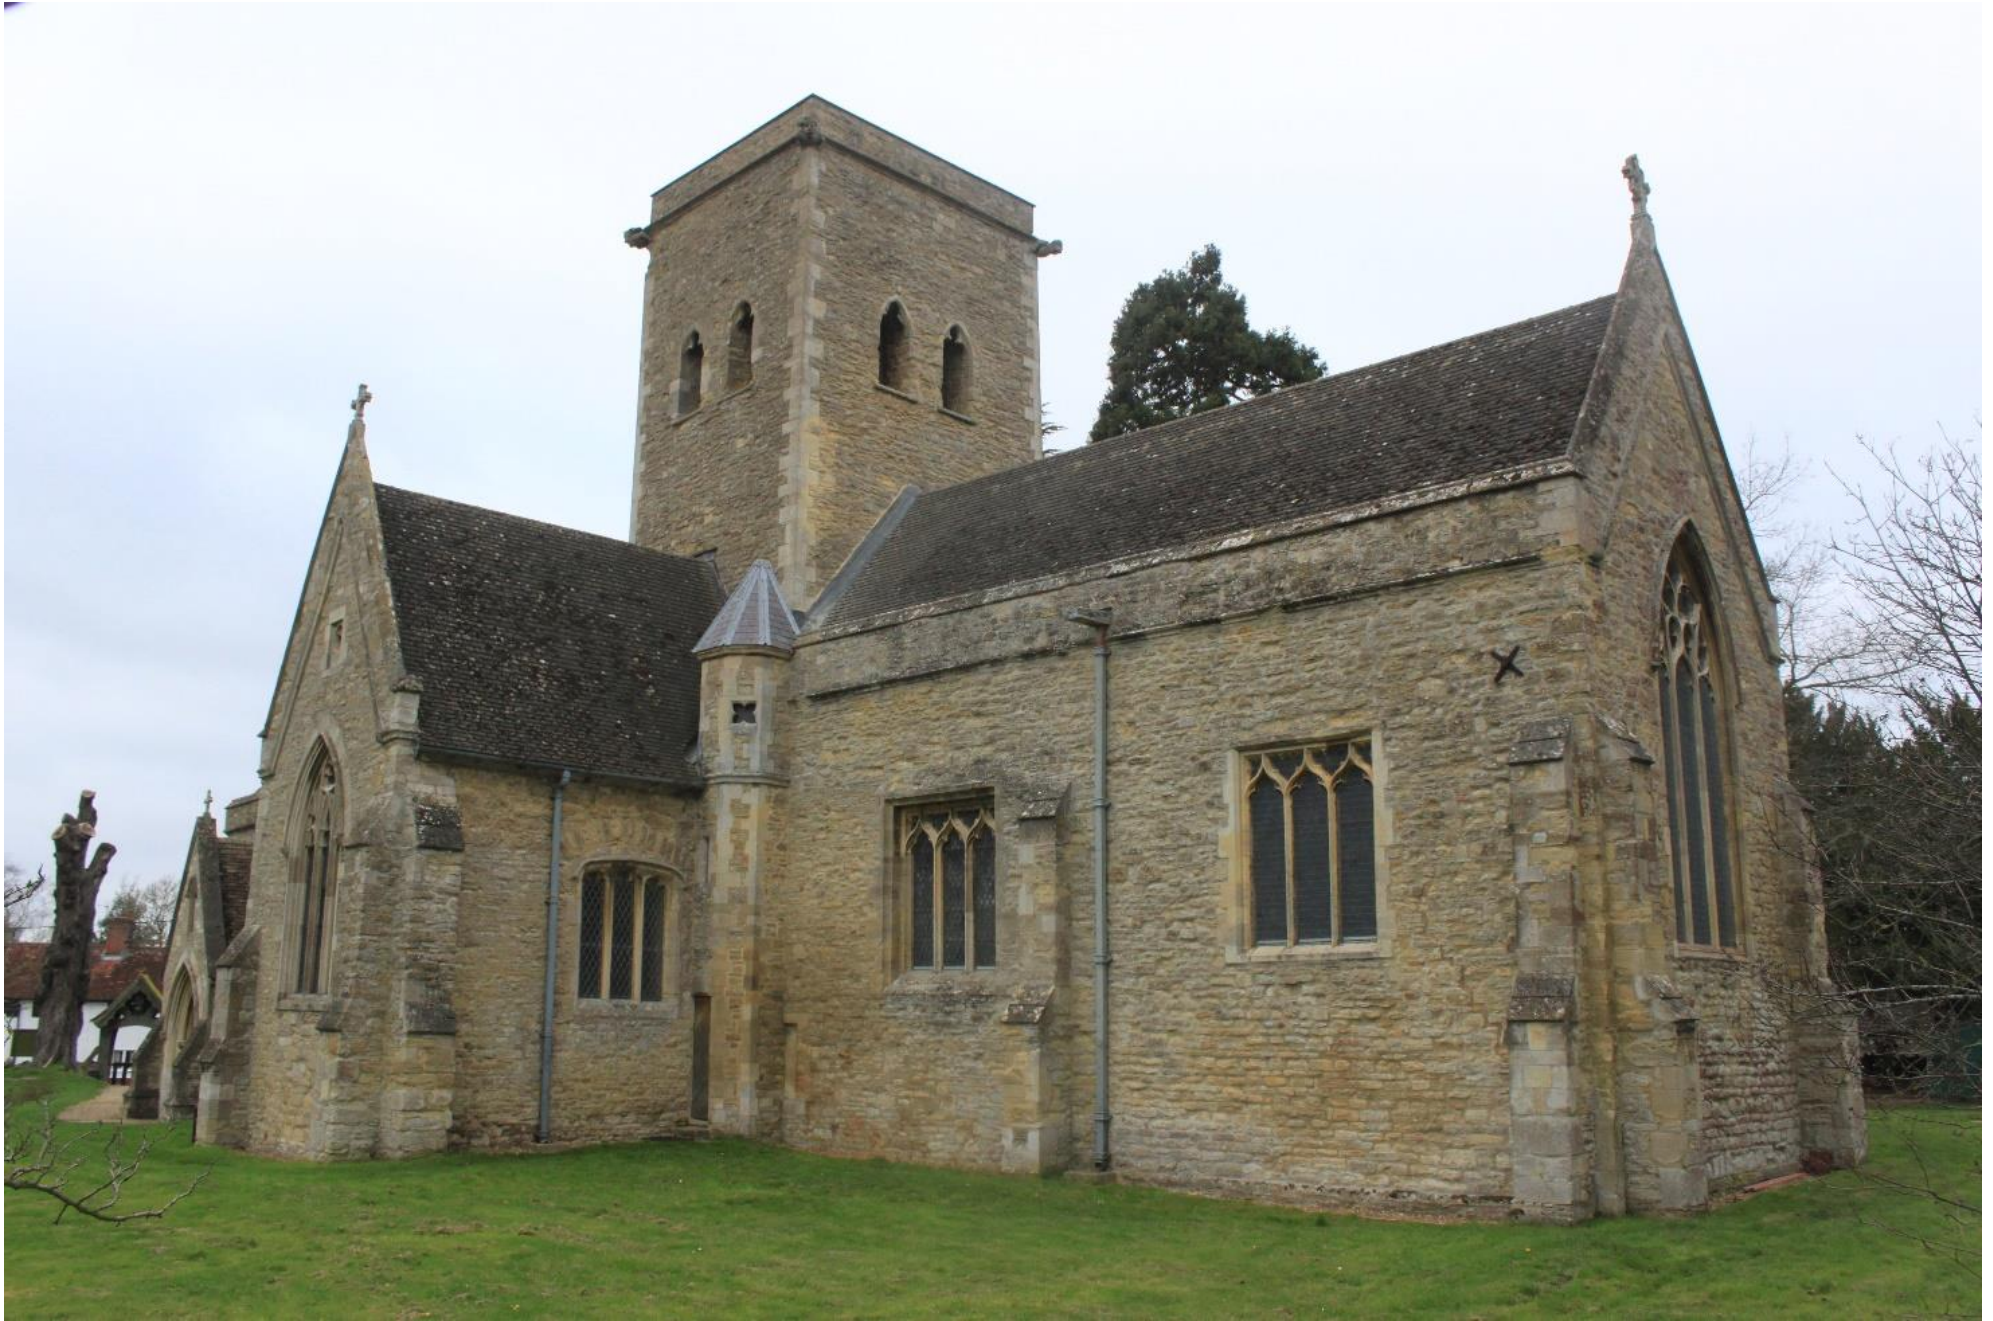
**Modern view from SE for comparison with Fisher pencil sketch of c1812 above – see caption for major alterations of 1860s restoration**  
*(David Baker)*
