# CHURCH OF ST MARY BLETSOE – RESTORATION OF CHANCEL AND VESTRY

## Progress report 1

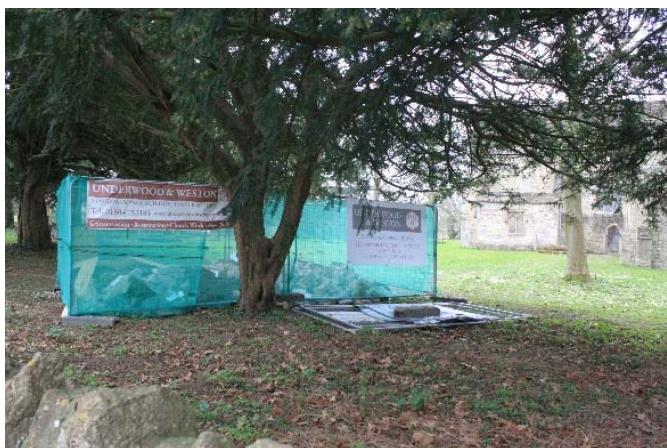
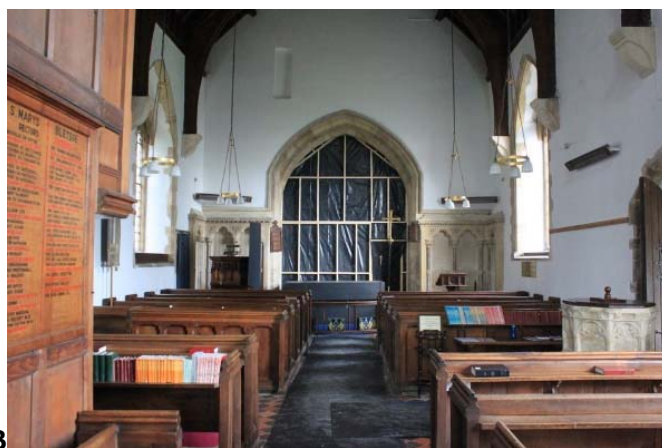
A B

2 Effective protection to enable continuing use of the nave and safeguard the organ was installed in the nave tower arch [B]; the reredos and Easter Sepulchre in the chancel have also been boxed.

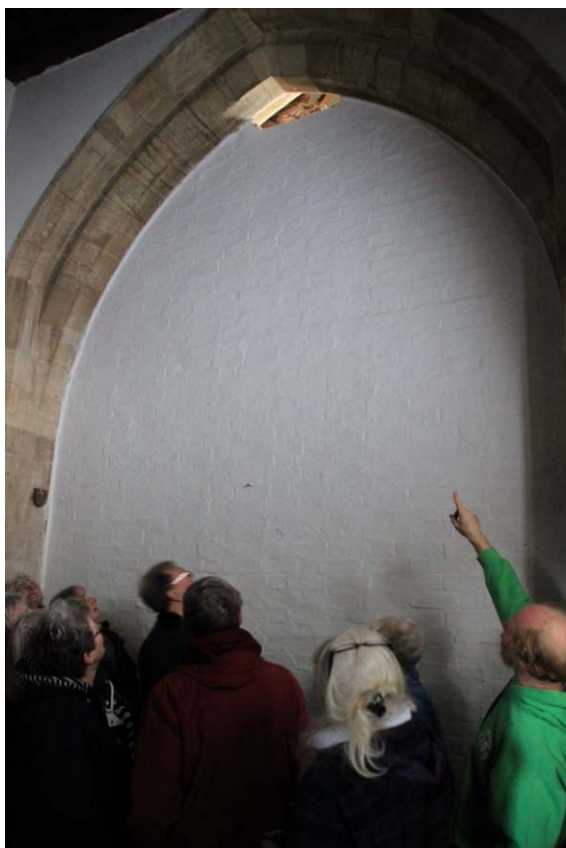
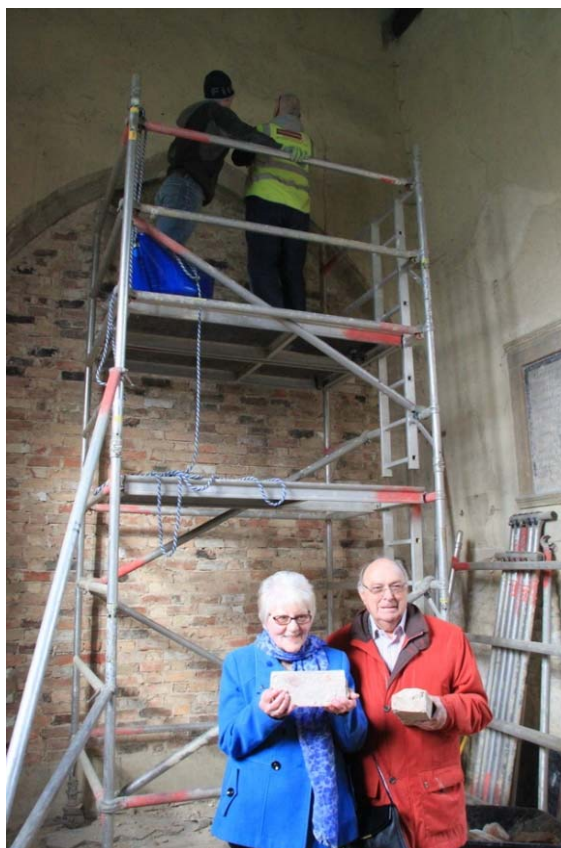
C D

3 The 1970s brick wall in the chancel arch is no more. Removal of the first brick in the apex was watched by an appreciative village audience on the west side under the tower. At the crucial moment a sunbeam on the other side of the new hole lit up a wooden angel in the chancel roof [C]. Two villagers who remember the wall being built were given souvenir bricks [D].

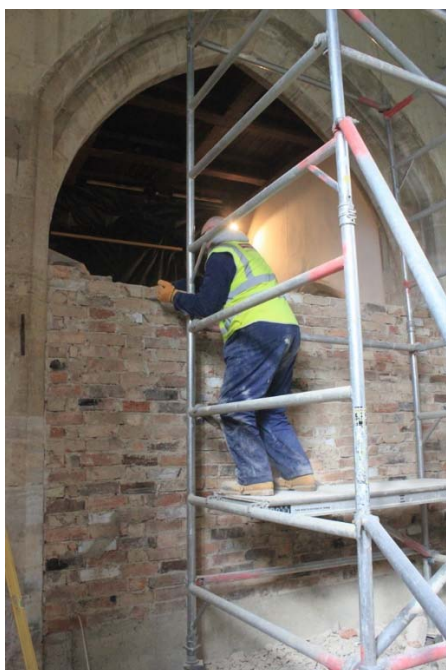
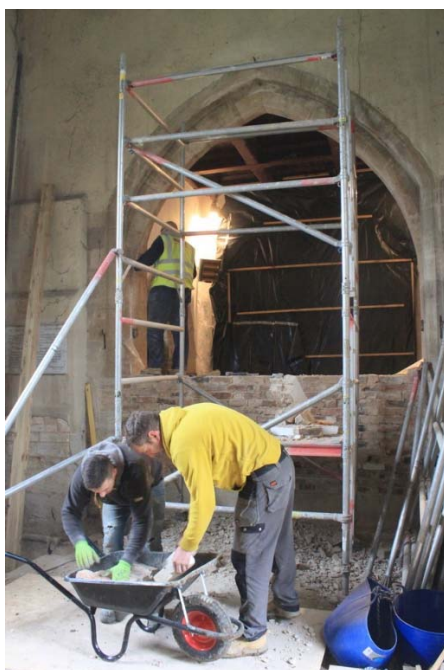
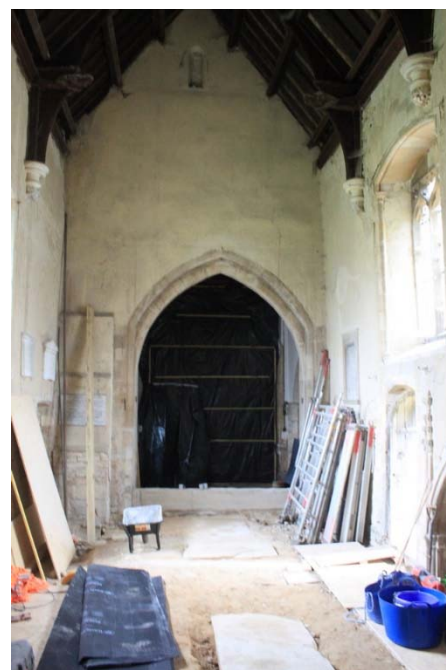
Going ....

.... going ....

.... gone

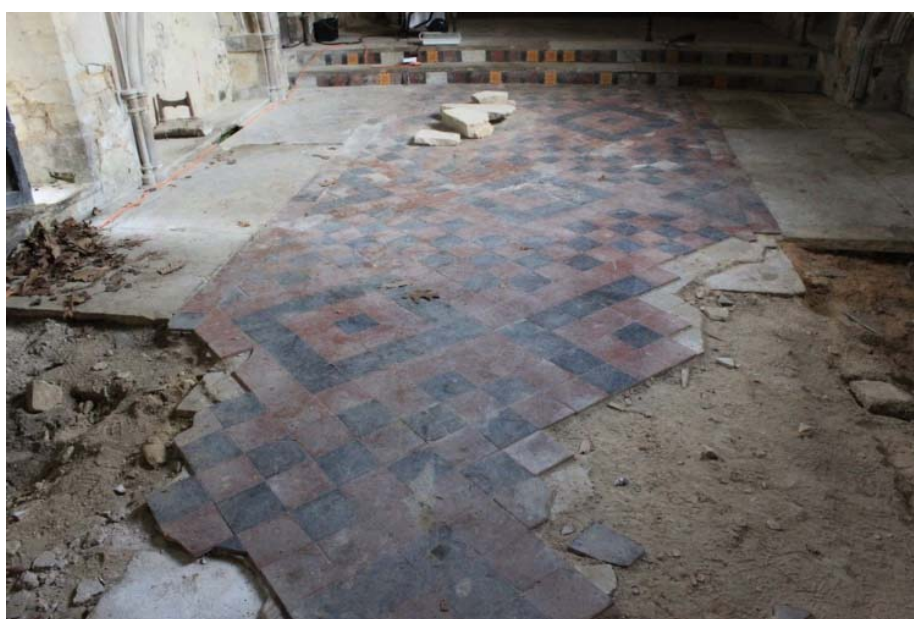
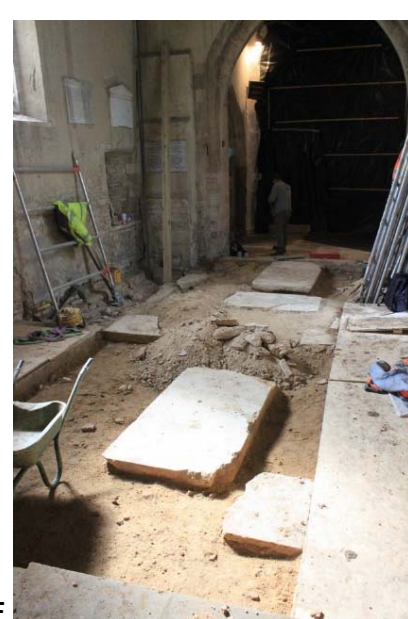
D E

4 The defective tiled floor [D] in the chancel was removed. Earlier damage and use of cement in the 1860s restoration meant relatively few tiles are re-usable. Un-evenness in the floor was partly explained by the discovery of memorial ledgers underneath it, mostly displaced from their original positions during the earlier restoration [E]. Surviving legible inscriptions were recorded by a village team [F]. One records the first wife, Ann, of Thomas Walker, an 18th century rector: she died in 1733. Thomas' memorial plaque (1770), also to his second wife, also Ann, who died in 1775, stands above on the north wall of the chancel. All three are recorded in the parish burial registers. The work of uncovering and deciphering the ledgers was recorded by students of Sharnbrook Academy Media Department who are making a video of the whole project [G]. All but one of the buried ledgers have been removed after recording; those with surviving lettering have been put to one side for future consideration. The large remaining ledger [E] will be lowered in its existing position so that it does not affect the new floor which will run over it.

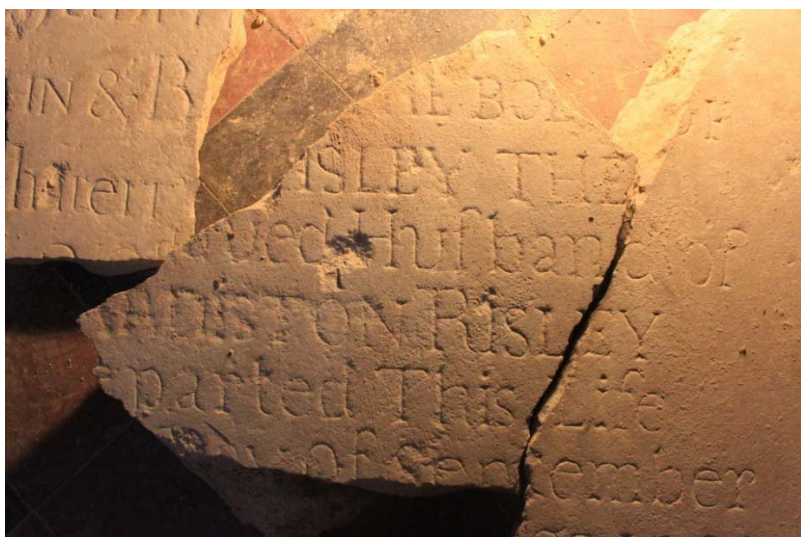
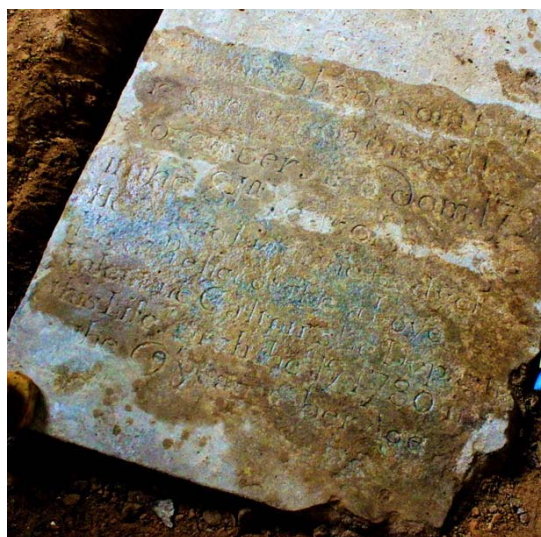
6 The floor of the vestry has been reduced to a new formation level which when completed will be the same as the chancel. This will enable wheelchair access on the level through enlarged 19th century doors which have been recorded archaeologically [K] in advance of their alteration. A trial trench dug in 2014 had encountered largely disturbed earth and rubble from the 1860s when the vestry was built, and this was confirmed.

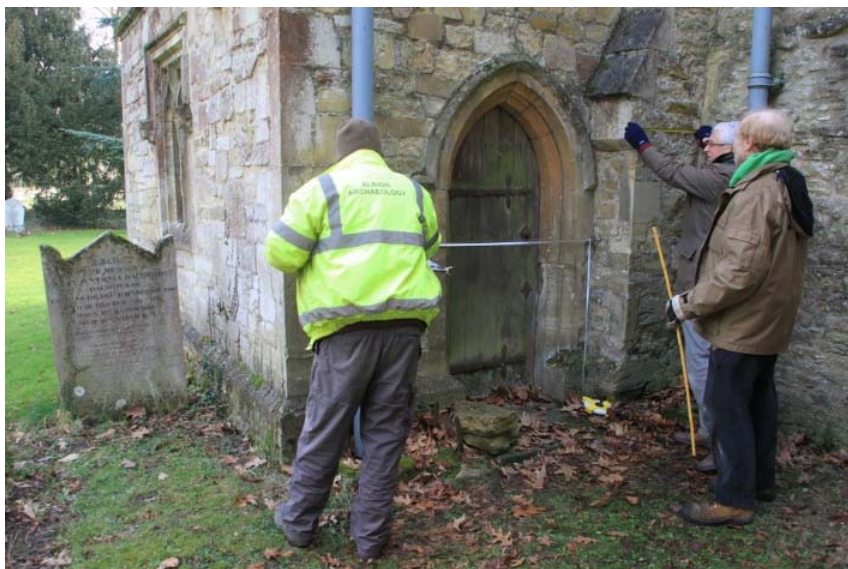
K L

7 Drainage trenches around the footings of the 1860s vestry showed how it was squeezed into position in what was then a much more crowded churchyard. One of the few headstones to survive the 1962 clearance, to Fanny Bainbridge 1831-1841, predating its construction and tight against its north side has been moved [L] for later re-siting slightly further north to accommodate the drain trench. Also on the north side was a brick-lined vault, predating the vestry and filled when it was built, with its south side just under the north wall. It was identified in the trial pit of 2014/15; removal of the two courses at each end allows the specified drain to be formed. Clearly the vestry has had structural problems in the past, with tie-rods on the inside and a massive underpinning of the north-east corner and north side.

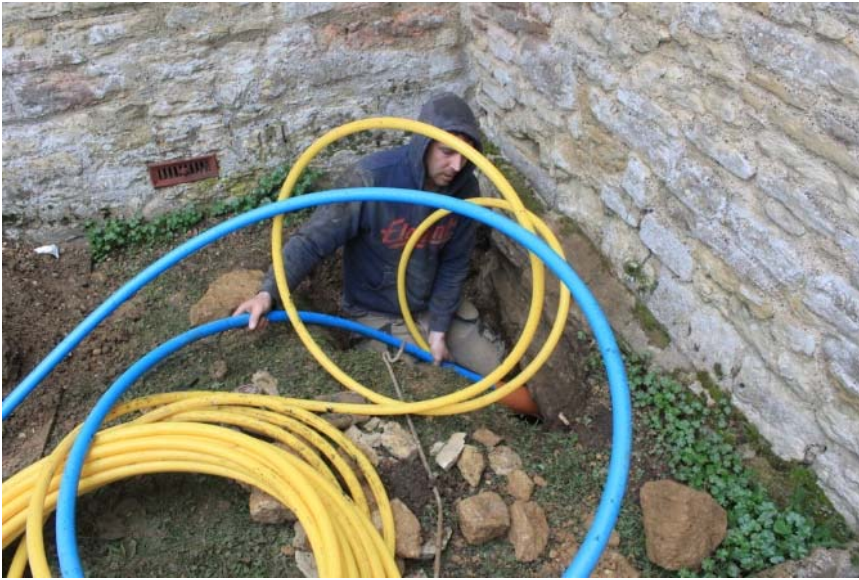
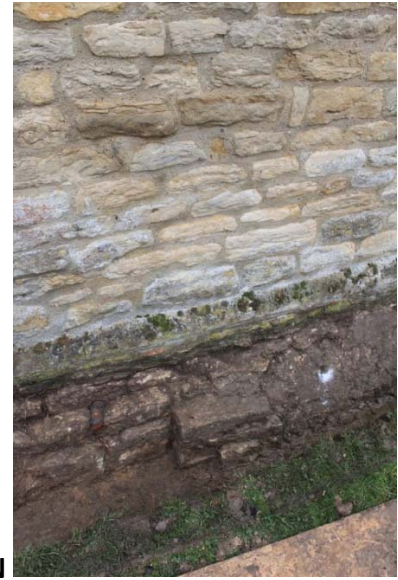
M N

9 Outside the chancel a proper drainage system is being installed to take rainwater away from the church and prevent further outbreaks of damp in the reclaimed parts. A trench dug around the outside wall exposed the upper foundations and provided new information about original construction [N]. On the south side, the chamfered offset is at a different level in the two bays of the chancel, suggesting it was built in two stages, and at a third, surprisingly lower, level on the east wall of the south transept. The chamfers were meant to be seen above contemporary ground surface, so should indicate changing levels within the adjacent churchyard – a matter raising more new questions. At the south-east corner of the chancel, modern concrete repairs to the foundations are part of earlier attempts to deal with the cracks in the wall above by the unreliable method of underpinning.

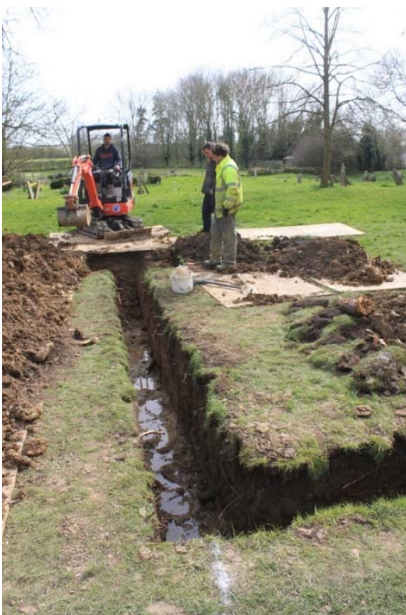
P

10 Digging out the trenches for the storm water / land drains on the south side has been completed in very difficult working conditions due to bad weather; inserting pipework and backfilling will begin shortly [P]. While gutters and downpipes on the chancel have been well maintained, there seems to have been no provision for taking the water away from the walls to a soakaway, thus explaining the problems of damp in the chancel. Careful digging of the new trenches with a toothless machine bucket located parts of up to nine burials, all probably pre-19th century. Recorded archaeologically before unavoidable temporary removal, the affected bones will be re-interred as close as possible to the point of discovery.
