# CHURCH OF ST MARY BLETSOE – RESTORATION OF CHANCEL AND VESTRY

## Progress report 2

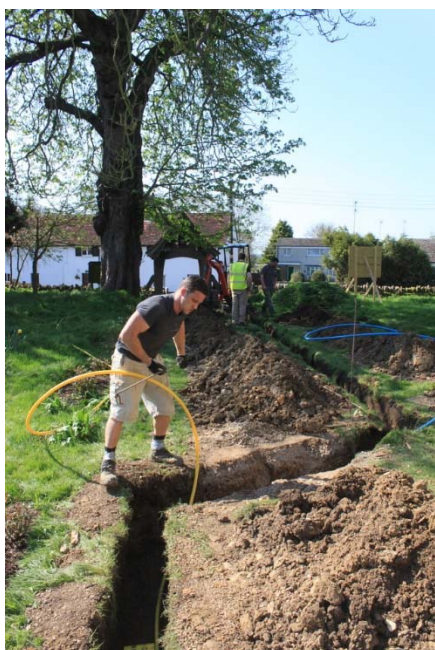
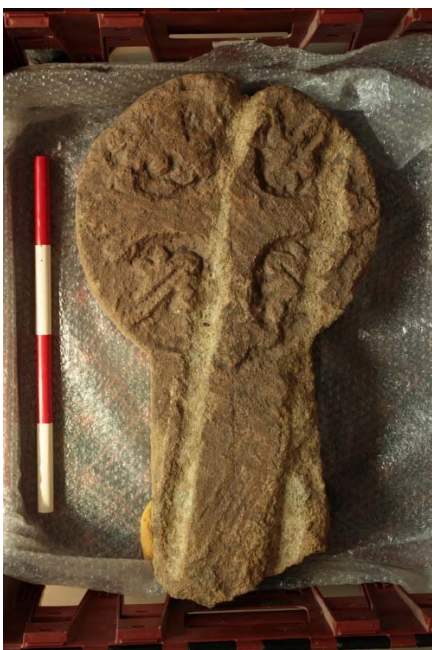
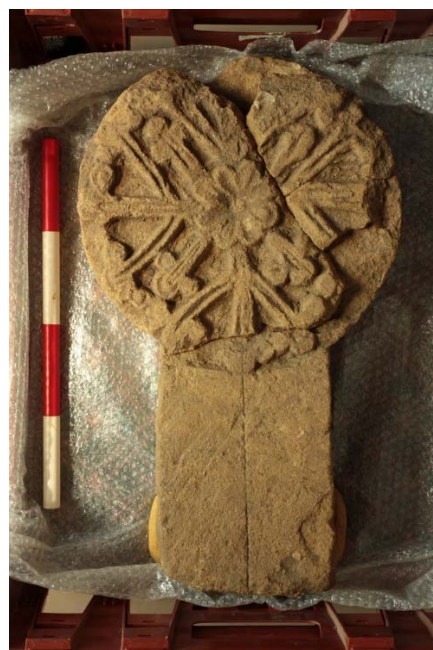
2 An unexpected find in the trench for water and gas dug from the lych-gate to the south transept was a **13th century grave marker**, in four pieces and not in its original position. It has a cross on one side and a rosette pattern (which gives the dating) on the other **A**. It probably was used to mark the churchyard rather than a particular burial. National and locally-based experts (Professor Paul Crossley - who lives next door to the church - and Professor Richard Marks) all agreed it is a fine example, one of the best found in England. It has been removed for safety to secure premises in Bedford with the agreement of the diocese until conservation can be arranged with the specialist firm of Skillingtons in Grantham.

**A** Service trench near find of 13th century grave marker: the marker before conservation which will include repair of damage

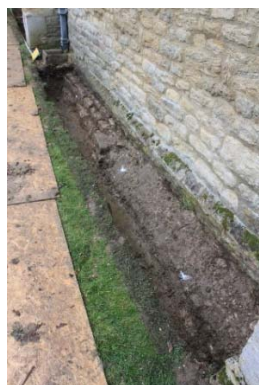
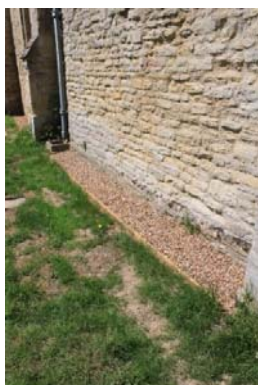
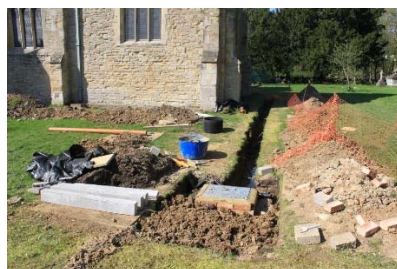
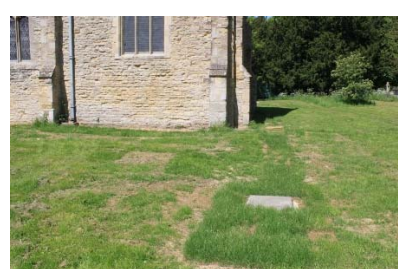
3 Completed gravel drains around the edges of the chancel and vestry run to new soakaways north and south of the church. Given the appalling weather conditions, the finished result is impressively tidy and the churchyard should recover its appearance fairly easily.

**B** Drainage north of chancel: footings exposed in trench; gravel-filled trench; drainage runs with soakaway in foreground; back-filled area.

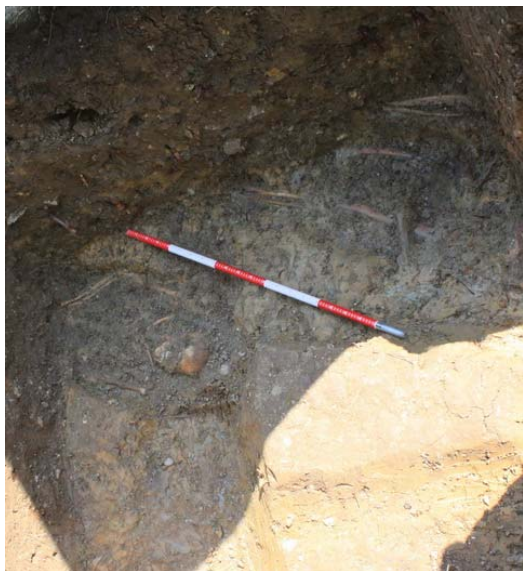
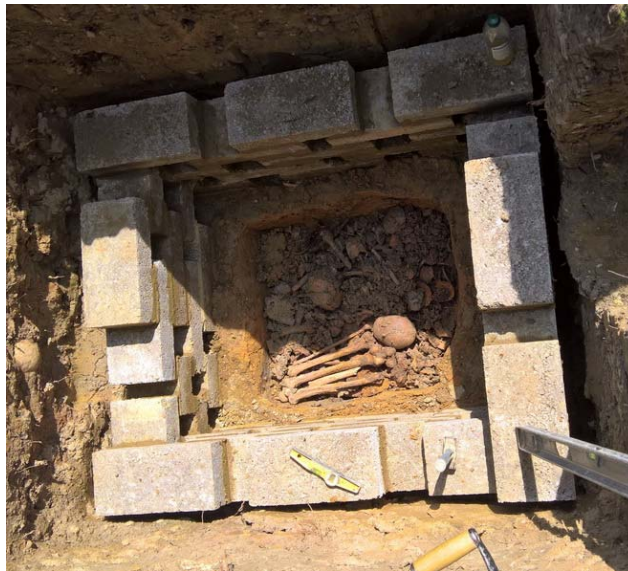
4 The soakaways are over a metre deep and excavation was carefully monitored archaeologically. Unsurprisingly in a churchyard used for centuries, parts of several skeletons were found just above and cut into the natural clay sub-soil. They were recorded, lifted and reburied as close as possible to the place of discovery after insertion of the pipework **C**. It was not practicable to re-route the drainage trenches and soakaways because the location of burials generally had been lost when the churchyard was cleared of headstones and kerbstones in 1962. There was little or no dating evidence with these individuals beyond some indications of the early 18th century on the south side soakaway.

**B** Left: burials found at base of drainage soakaway pit Right: reburial after construction of soakaway

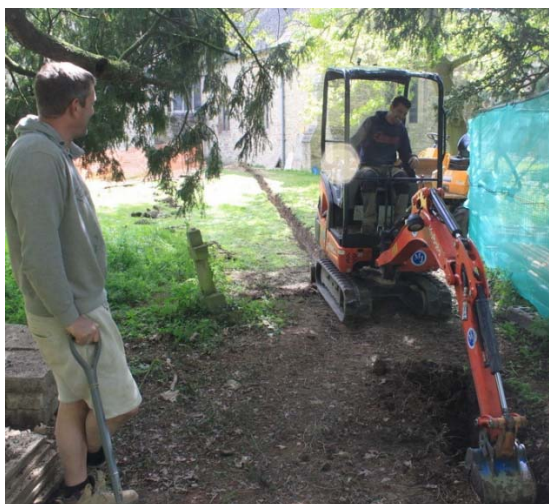
5 Finding the general depth of surviving burials prompted redesign of the new drain from the kitchenette and toilet north to the sewer in Coplowe Lane. Instead of using gravity-fed pipes up to 2m in depth by the time they reach the churchyard wall, outflow will be pumped in pipes in a trench about 0.5m deep, thus avoiding damage to major tree roots and burials. The extra costs of a pumped system will be partly balanced by a shallower trench and the lack of delays in digging it due to the discovery of burials – and the approach was confirmed when the shallower trench was dug **D**.

**D** Digging the modified shallow drainage to Coplowe Lane

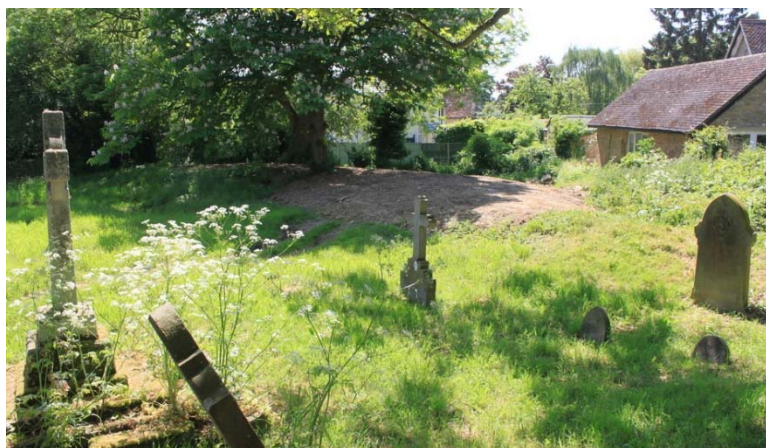
6 The problem of where to put surplus soil generated by the drainage and digging out the damaged floors in chancel and vestry has been neatly solved. There is now a low sweeping bank in the south corner of the churchyard extension where previously there had been long-accumulated tipping and brambles – a definite improvement for views within the churchyard and from outside it **E**.

**E** Landscaped bank for surplus soil in churchyard south corner

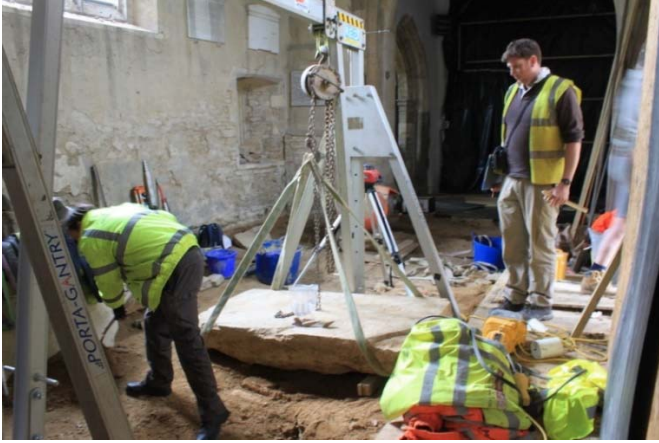
7 Inside the chancel, lowering the existing floor to the depth required for building up the new one confirmed that at least 500mm of material had been imported in the 1860s restoration. George Baxter and others heroically moved much of it; the experience was archaeologically disappointing but a simpler piece of preparation than had been feared. Ledgers hidden under the 1860s floor had to be re-sited so as not to cause problems for the new floor. In the largest case it involved heavy lifting gear to enable resettlement at a lower level **F**. The ledgers along the sides of the chancel, retained as part of the new floor, have been properly supported with new material under their edges to avoid future subsidence and unevenness **G**.

**F** Resettling a large ledger for reburial under the new floor

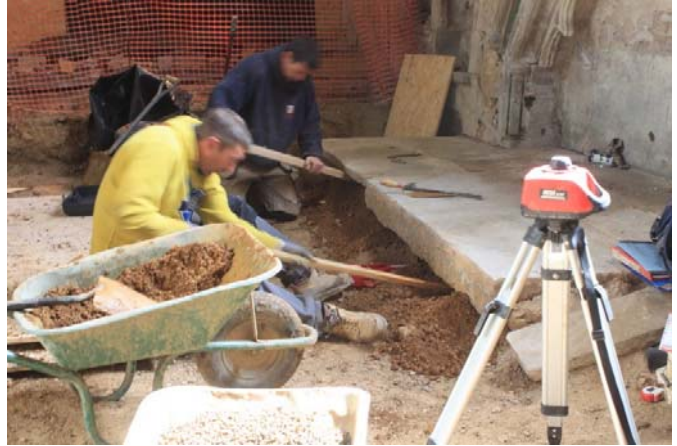
**G** Packing ground under ledgers retained for the new floor

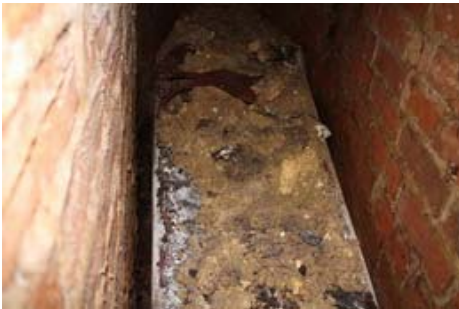
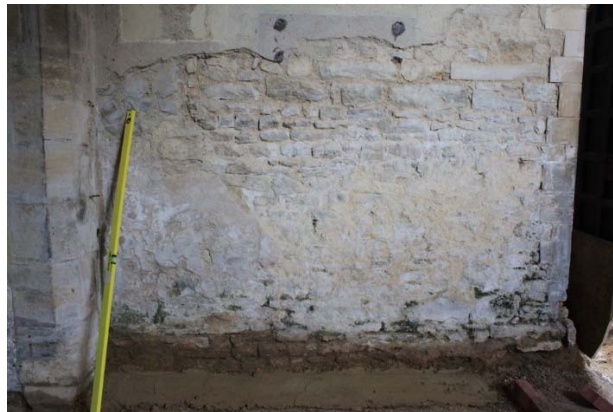
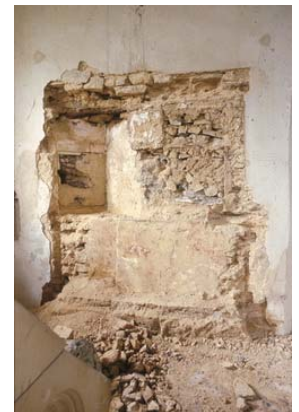
8 The two brick vaults found at the west end of the chancel do not need to be disturbed in order to create the new floor. The requirement for a small repair where old damage had dislodged a brick in the side of the northern one enabled Mark Phillips of Albion Archaeology to make a photographic record. It contains a lead coffin with the decayed remains of the timber on top and fragments of mortar from the vault roof. It is probably related to the wall plaque above it, discussed in our first report **H**.

North side chancel: **H** Coffin in vault; **J** Wall opposite squint in St John Chapel; **K** blocked squint behind site of St John memorial

9 The area of wall without plaster above that vault **J** is on the other side of the wall in the St John Chapel where the St John memorial stood until it was moved in the 1980s (to the north side of the nave). Behind it was the remains of a *squint* **K**, giving a view from what then would have been a medieval chantry chapel through the wall to the then main altar in the chancel. A chantry chapel was a special place for a priest employed to say masses for the soul of his patron; the first reference to one in Bletsoe dates from 1279 when John de Pateshull (the lord of the manor at Bletsoe) presented the priest Nicholas de Sarnebroc' to "a chantry in the chapel lately founded". We examined the wall on the chancel side for traces of the other side of the squint, which would have gone out of use probably with the 16th century Reformation. There are definite irregularities in the stonework but it is difficult to see any obvious evidence and later repairs may have removed them.

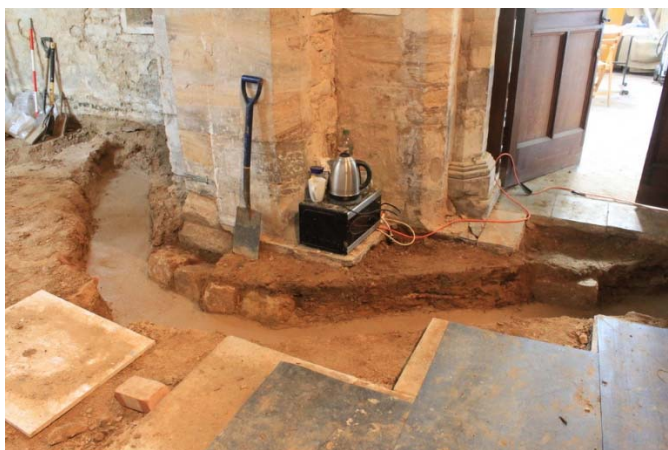
installed in the vestry. They have to skirt round the massive pier foundations supporting the tower **L**. The common-brick channels put in them **M** and the pipes to be put in the channels will be entirely invisible when the new floors are built over them.

**L** Services channels running from the south transept (right) to the site of the future kitchenette (left)
