# CHURCH OF ST MARY BLETSOE – RESTORATION OF CHANCEL AND VESTRY

## Progress report 3

**31 August 2018**

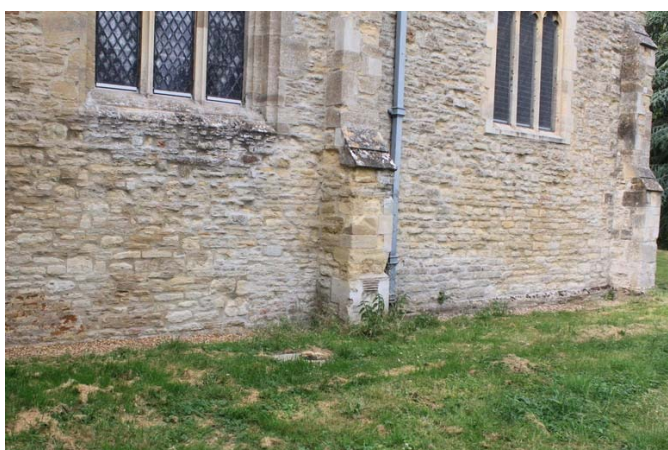
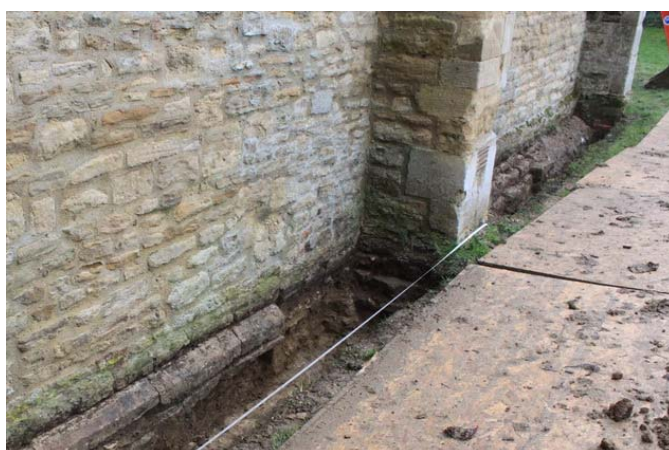
3 We have learnt more about the complicated **development of the 14th century chancel** from studying evidence shown by the drainage trenches dug around its walls. An important indicator is the height of the chamfered offset to the base of the outside wall face, at a relatively fixed level above the ground surface when originally constructed. That surface has been rising due to continuing burials, so the

different levels of the chamfer on various parts are a clue to the sequence of building (**C, D**). Taken with the very slight bend visible half way along the inside of the north wall and the change in the character of the exterior stonework half way along the south wall, this evidence confirms the chancel was doubled in length in the 14th century, from a one-square to a two-square plan, reflecting the prosperity and piety of the Pateshull family, lords of the manor, at that time. It also explains why the angle of view through the *squint* between the chantry chapel in the north transept (now the St John chapel) and the chancel, described in the last report, points at an altar position at the east end of the earlier half-length chancel. This complex story will be explained in more detail in the new guide to be prepared as part of the Heritage Lottery Fund's contribution to the project.

South side of chancel showing (left - **C**) different stonework coursing on the doubled length to the right of the buttress, and (right - **D**) in the drainage trenches the chamfered offset at a lower level on the original shorter chancel to left of the buttress.

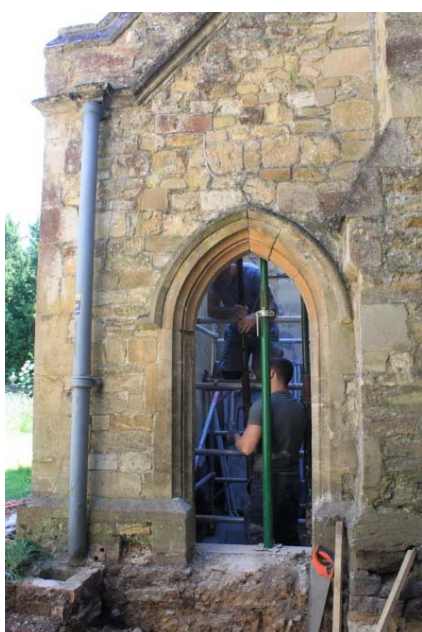
Vestry door enlargement: **E** before

4 The last piece of excavation lowered the ground between the west side of the vestry and the north side of the chancel, so that level wheelchair access will be possible from the new floor in the chancel to the disabled WC in the vestry. This also enabled digging the service trenches from the kitchenette and WC out to the sewer in Coplowe Lane and inserting the pump mechanism, all below the future finished ground level. Part of this exercise involves widening the two doors, and **work on the main entrance to the vestry** has been virtually completed. It was a delicate task, propping the wall above the door head, partly dismantling the stonework and then reassembling it in the wider position, with a new keystone (**E – J**).

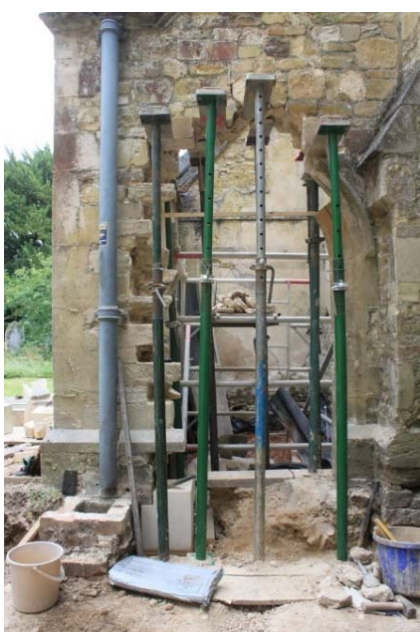
**F** propped during work

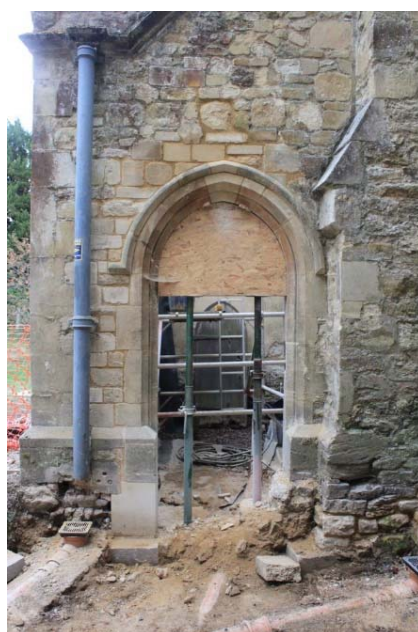
**G** nearly complete.

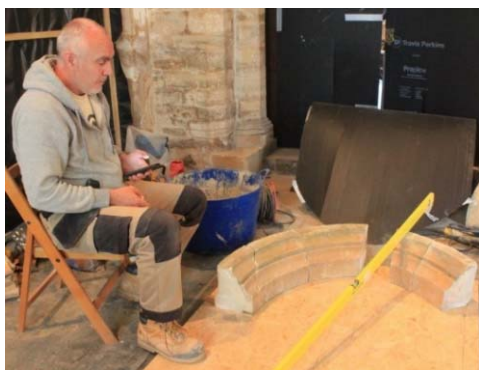
H measuring the enlarged arch

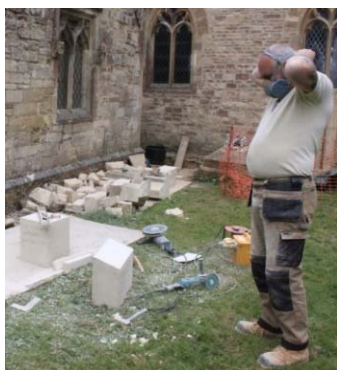
I preparing to cut new stone

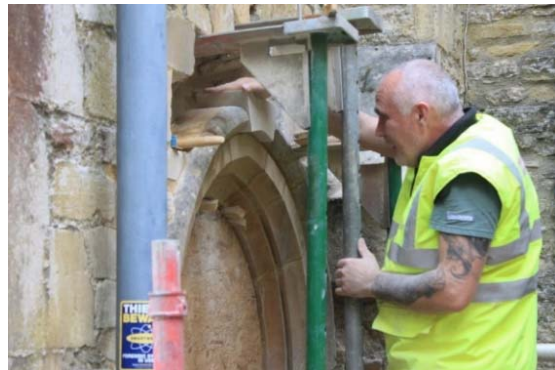
J easing the new keystone into position

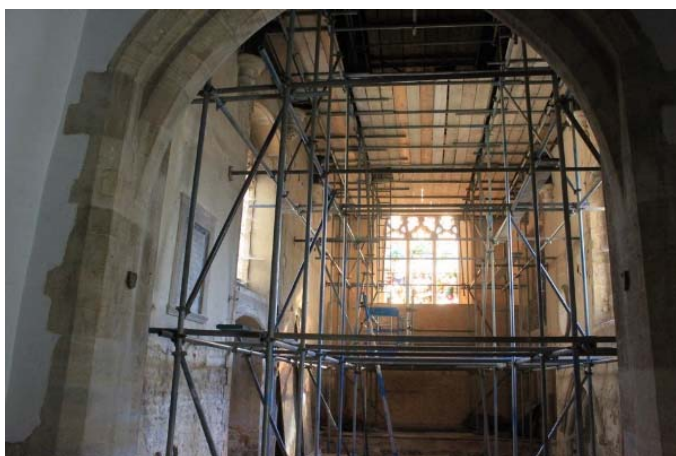
K Chancel interior scaffolded for ceiling lining and wall plaster repair. L Thomas Fisher’s sketch c1810 showing original pitched medieval roof line against the tower; its flatter pre-1866 successor is invisible below the level of the parapets.

5 Another example of ‘doing things in the right order’ is putting up the **scaffolding in the chancel** for getting access to the roof and re-plastering the walls, before building up the new floor, so that its weight, however carefully spread, does not damage it before the limecrete used in its construction has fully set (**K**). At the time of writing, the electricians have extended the wiring already installed at ground level so that it will be able to serve the new lights in the chancel, but the main work from the scaffolding has not yet begun. One exception is recording the **eight carved angels** which form part of the 1866 roof structure in their ‘before’ condition, cobwebs and bat droppings and all (**M – Q**). The main timbers of the roof structure appear to be in good condition, as might be expected after only 152 years, despite the problems of the 1970s which led to the current project. It is interesting that the 1866 roof structure, with its fairly steep pitch, replaced a much flatter, presumably 14th century, predecessor, itself replacing a still earlier steep-pitched roof whose gable-end line can be seen on the pencil sketch of c1810 by Thomas Fisher (**L**). The whole cost of the Victorian restoration and re-roofing of the chancel is recorded as £460-17s-0d.

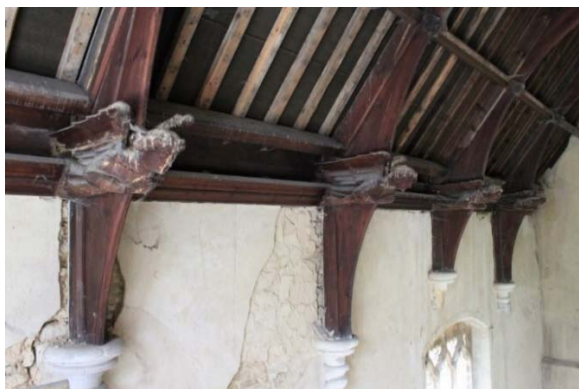
M The angels up in the eaves.

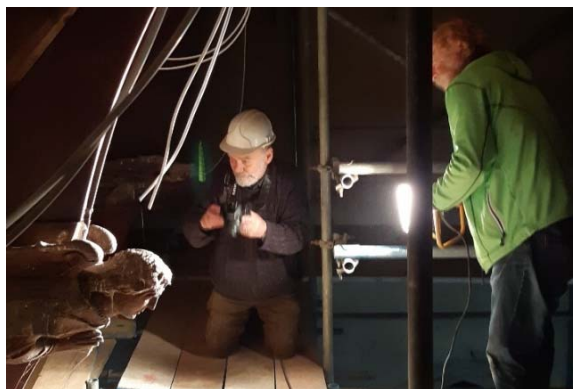
N Preliminary recording ‘as found’ by volunteers

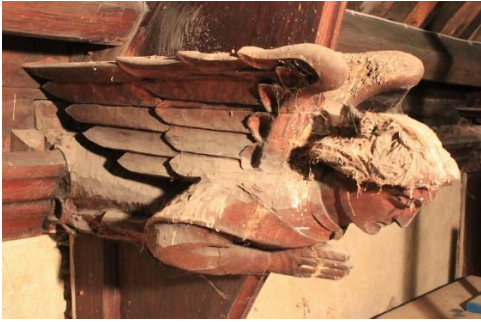
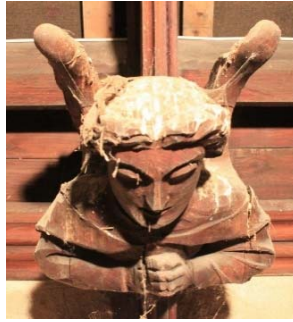
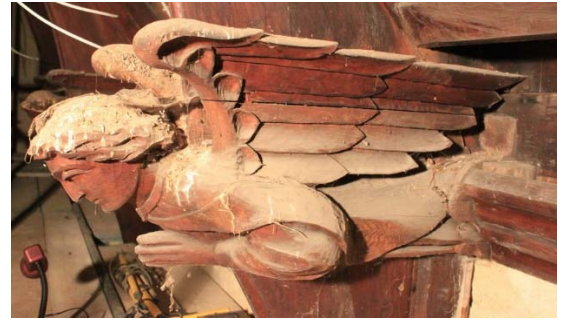
O, P, Q 'Before' record of each of eight angels, showing good condition despite several decades of neglect due to inaccessibility
