## 2010 repairs

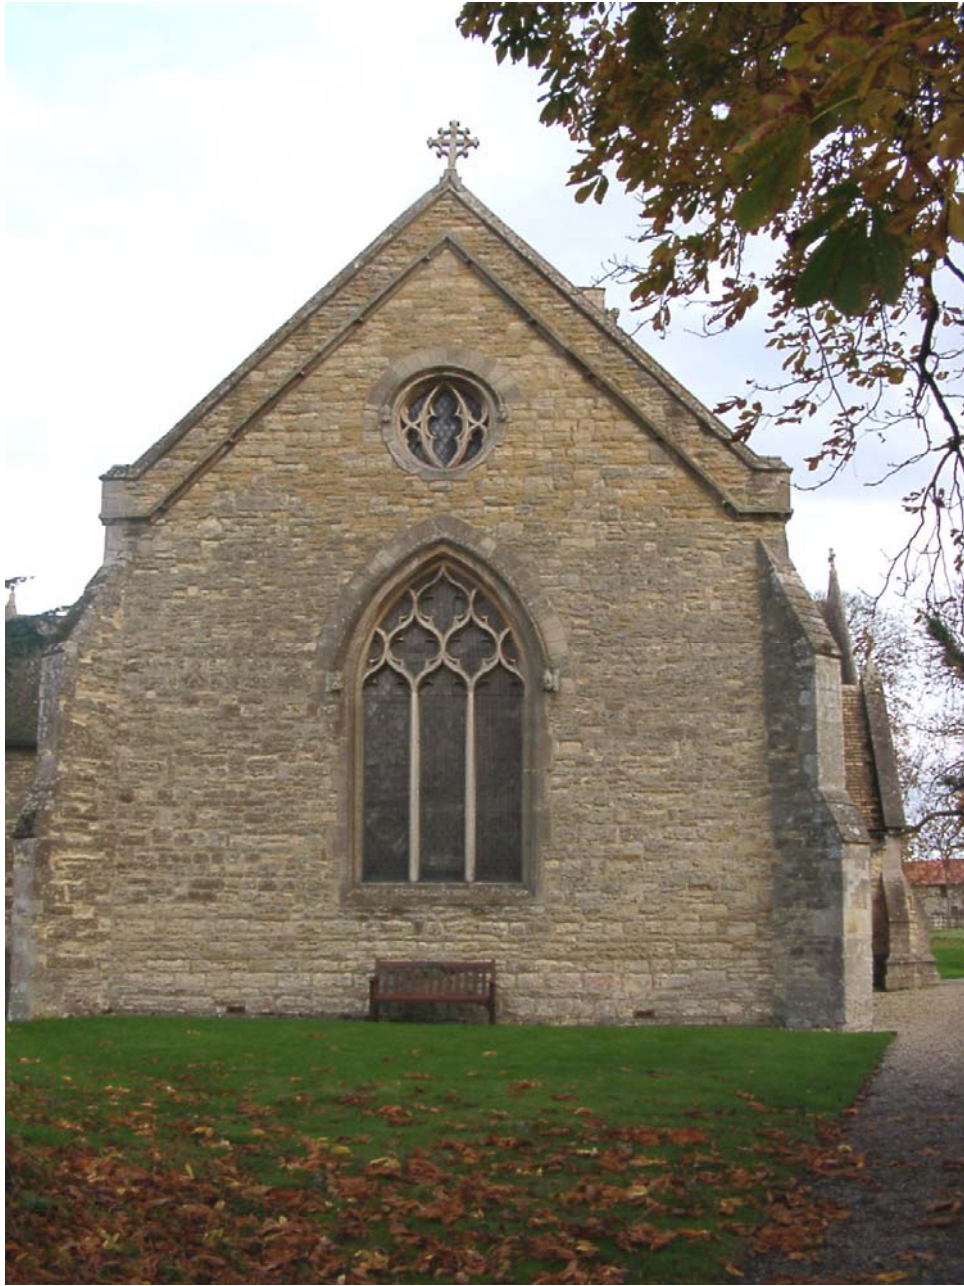
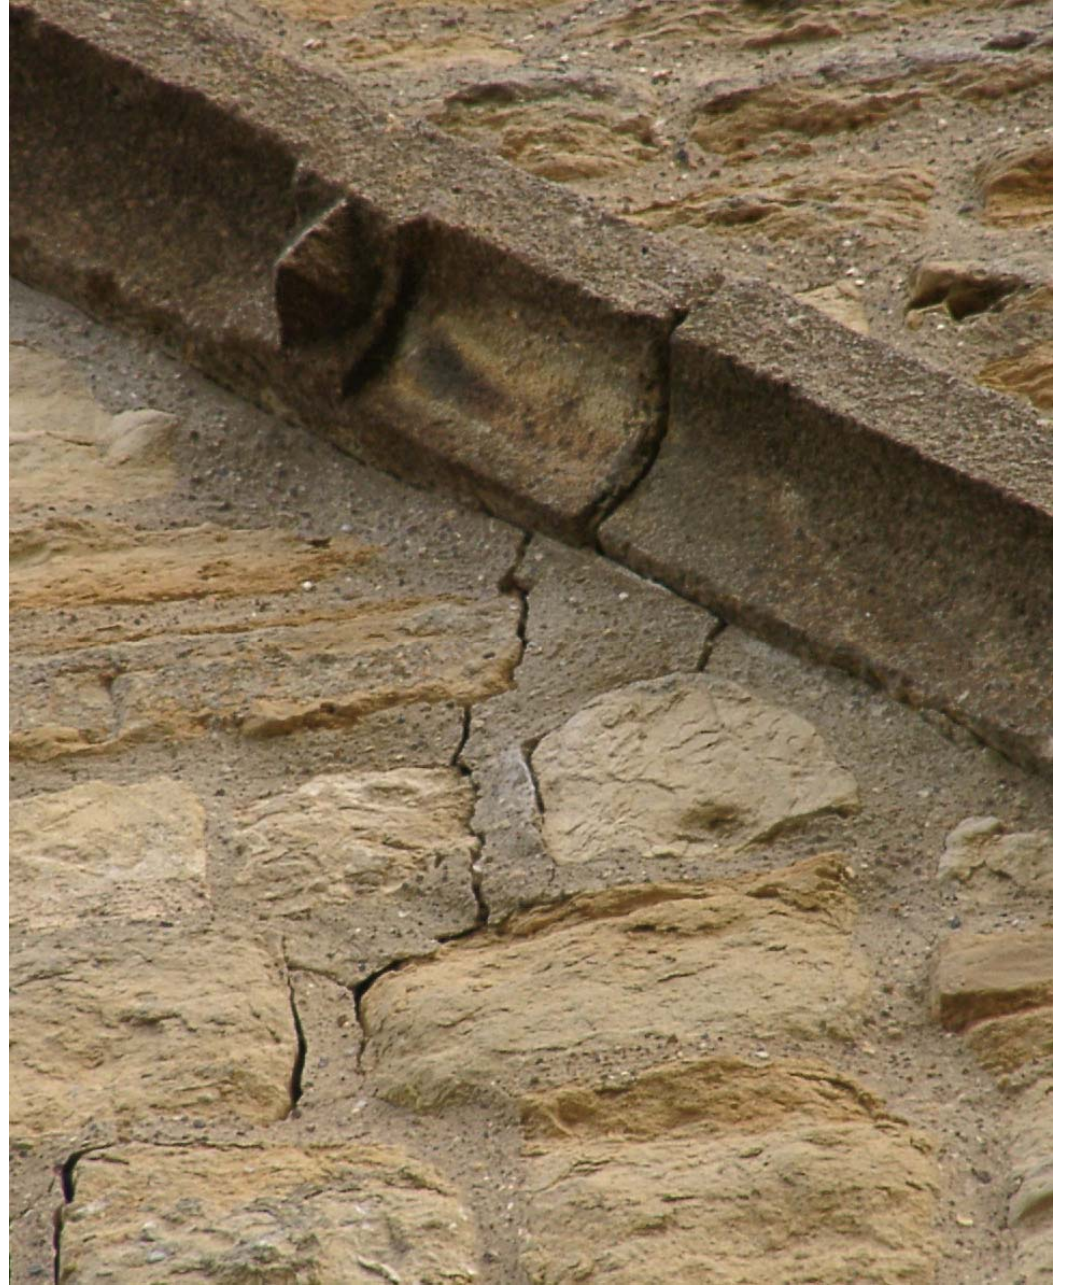
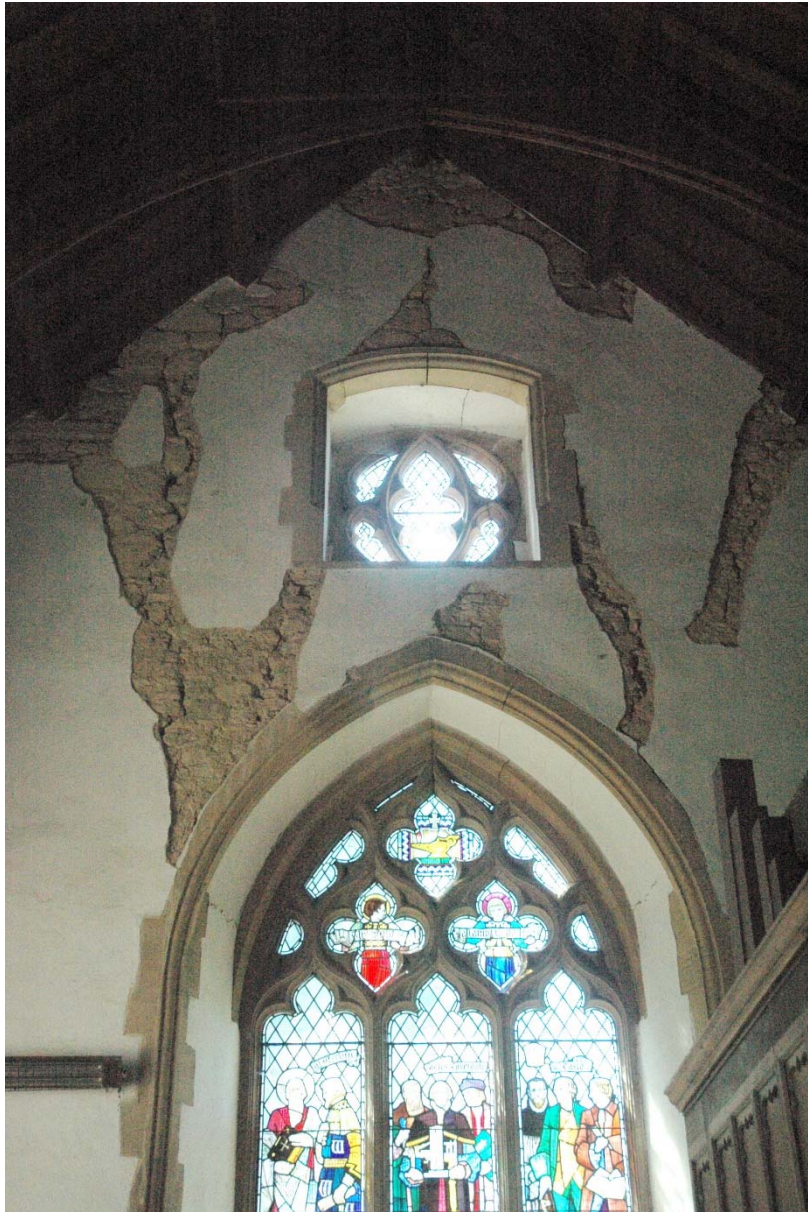
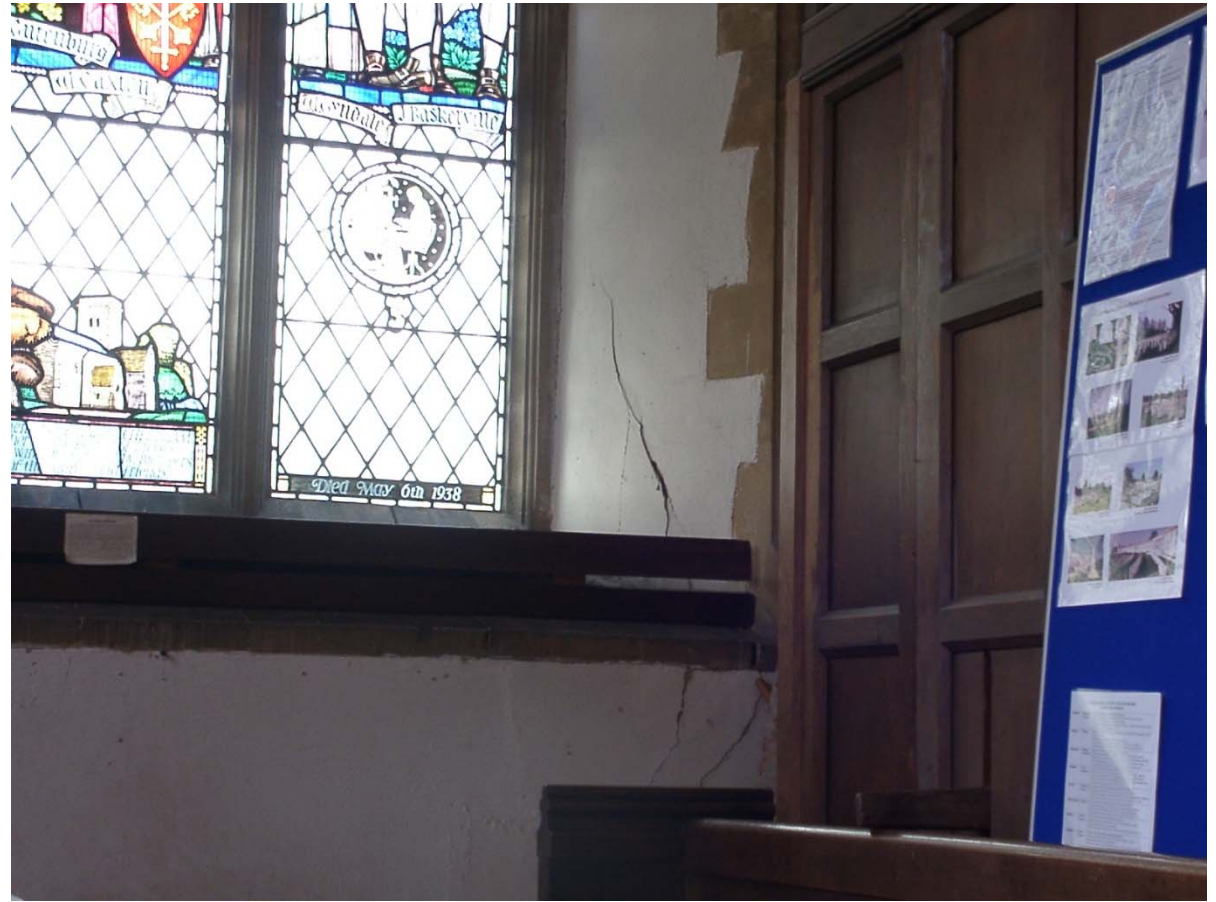
Clay-heave cracks in nave walls. (Above) west wall showing cyclical cracks also visible on 1940s pictures; (below) internal view (left) after plaster removal
