### 2010 nave cracks repairs

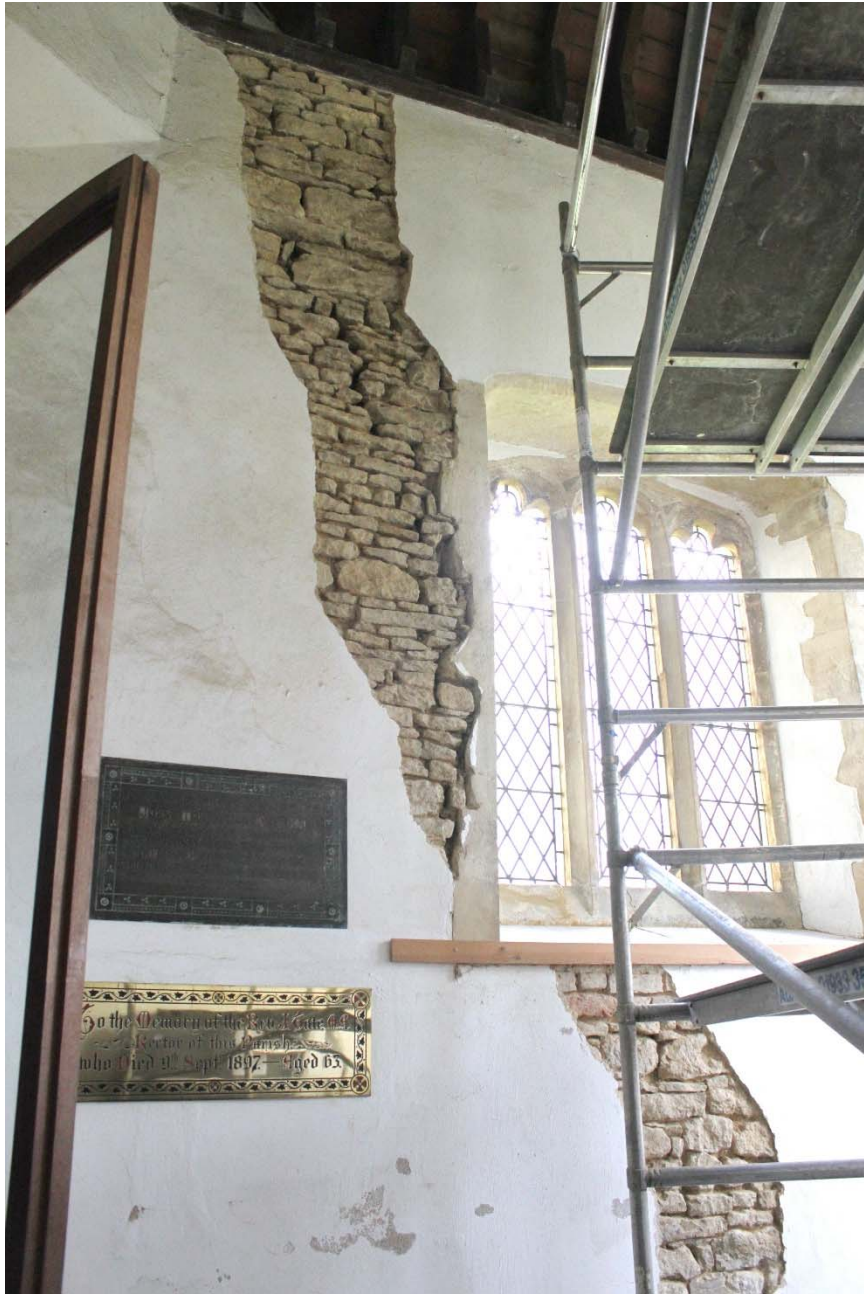
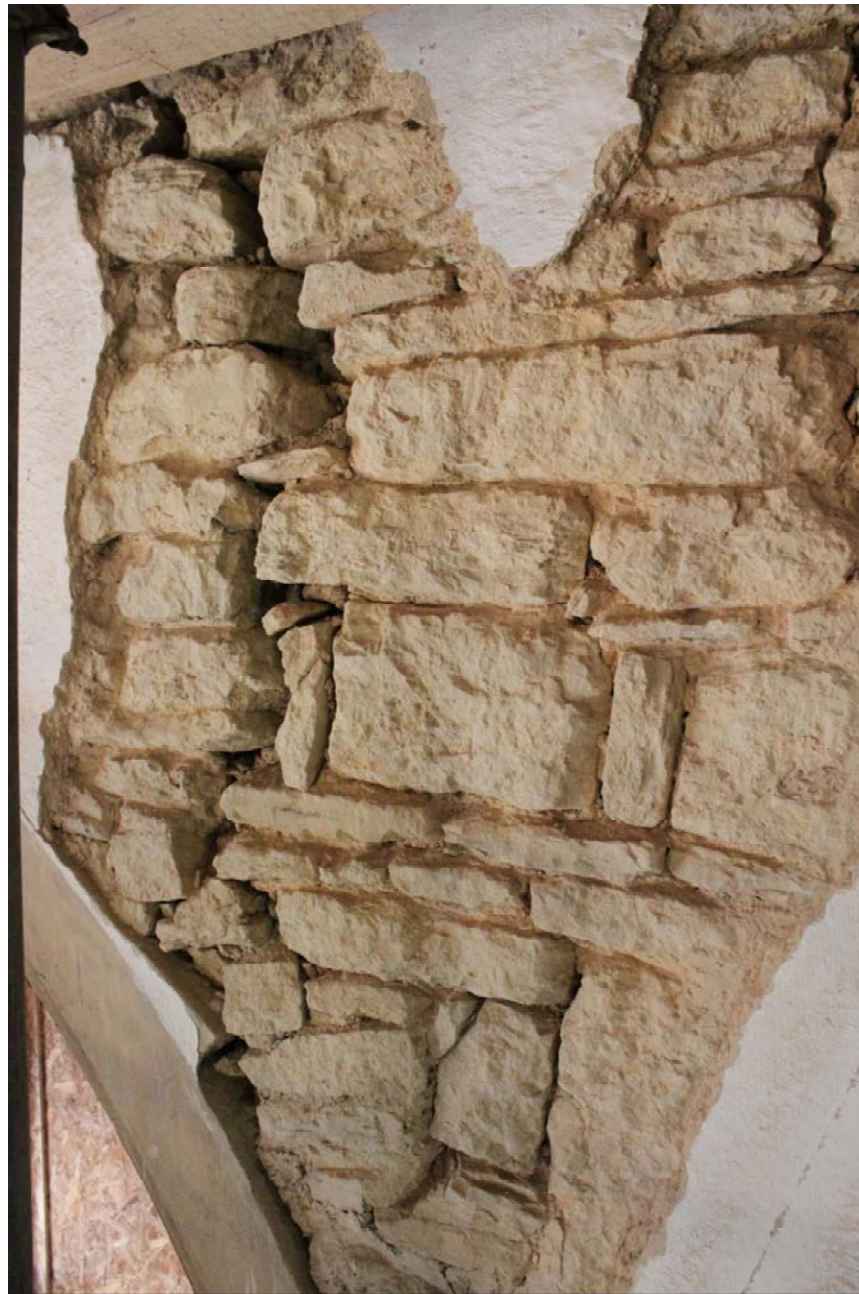
Before re-plastering the cracks were filled with soft mortar to allow further movement without greater damage and pins were inserted across the gaps.
